HAULER TOWER COLLAPSES

Daniel Fraser

ABSTRACT

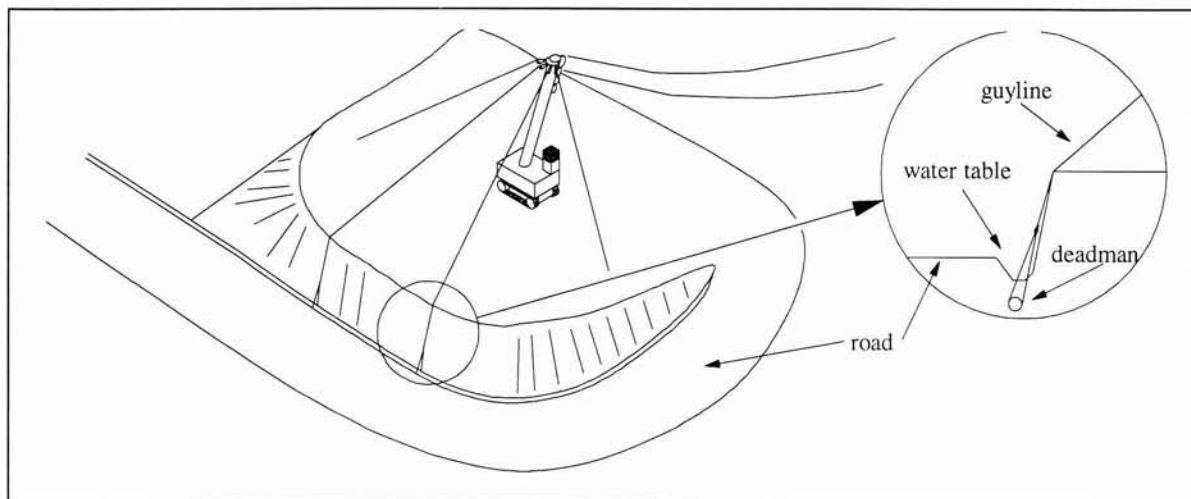
Figure 1 - Guyline arrangement before failure

- The back quadrant guylines passed through the tower sheave and down at a very steep angle to the deadmen.

- The lower part of the guylines passed over a cut batter then dropped at a steeper angle down to the deadmen (Figure 1). A "T" shape was not cut out of the side of the trenches to ensure the guylines were straight.
- The deadmen were buried in a water table.
- The extra forces from the jammed drag pulled the deadmen straight up and out of the trench.

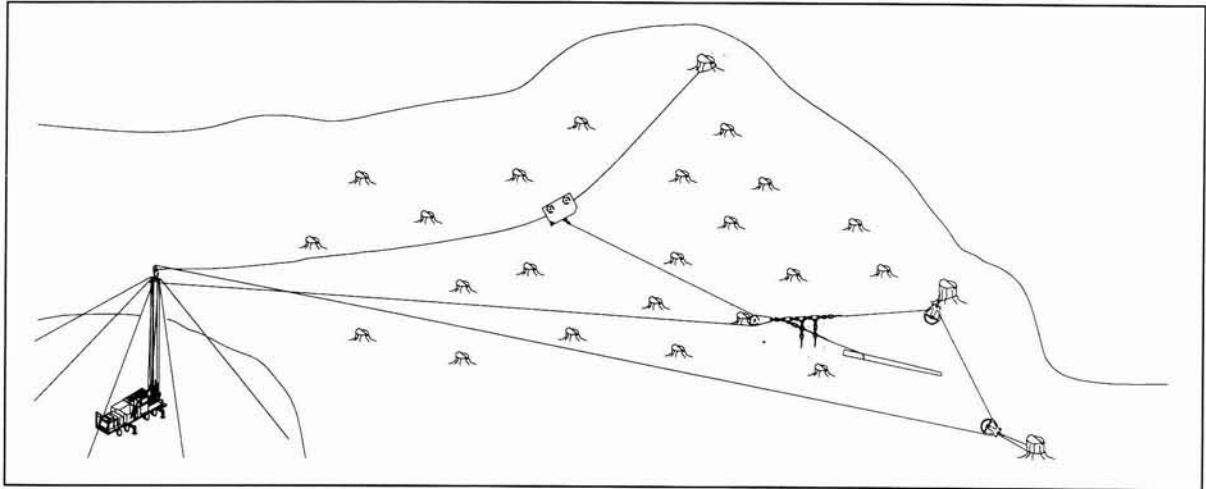
Figure 2 - Mainrope hung up on stump

The hauler was using the North Bend system in an area with very little deflection, bridling approximately 50m from the skyline. As the hauler attempted to break out a drag, the mainrope caught behind a stump (Figure 2). Before

the hauler operator could stop, two guyline stumps pulled out and another two shore off. The tower fell to the ground on its side.

- When the mainrope first caught behind the stump, the breakerouts did not signal to the hauler operator to stop.
- The hauler operator continued to apply pull on the mainrope when the excessive tension being applied should have signalled the operator to stop.
- The guylines had not been shifted after a large change in the direction of pull. One guyline was in the direct line of pull; this was the first stump to fail.
- Heavy rain the previous day probably decreased soil strength.
- The roots of one stump were damaged from previous logging.
- The breakerouts had previously used radios for communication, but on this occasion were using the Talkie Tooter only.

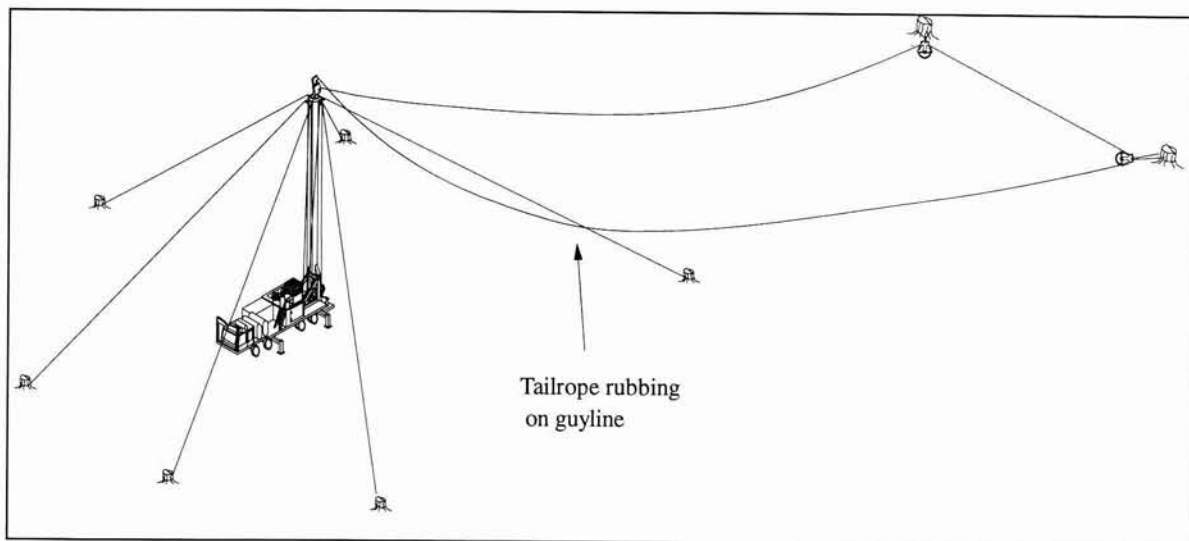
Figure 3 - Tailrope rubbing on guyline

The hauler had finished working one corridor and was shifting the lines to the next. The guylines were not re-adjusted and the crew did not notice that the tailrope was touching one of the guylines. The tailrope cut through the guyline reducing the stability of the tower to such a degree that the tower collapsed.

- The primary cause of this tower collapse was the guyline being severed by the tailrope. This was due to failing to prevent the guyline from touching the tailrope
- Had the six guylines been spaced evenly, the loss of one guyline would not have been enough to allow the tower to collapse.
