Performance of naturally durable eucalypt posts in Marlborough Vineyards

Paul Millen
NZDFI Project Manager,
Marlborough Research Centre, Blenheim

SWP project to assess performance of VT posts in Marlborough vineyards

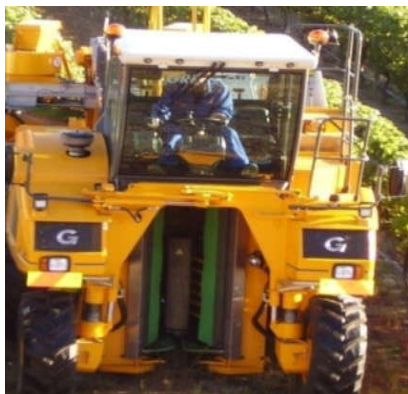
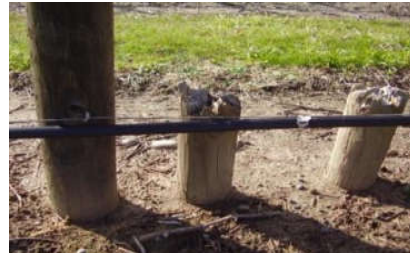
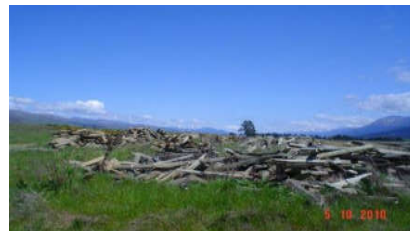
3% to 5% of posts break annually

>95% of vineyards use CCA pine posts that are broken during mechanical harvesting and pruning.

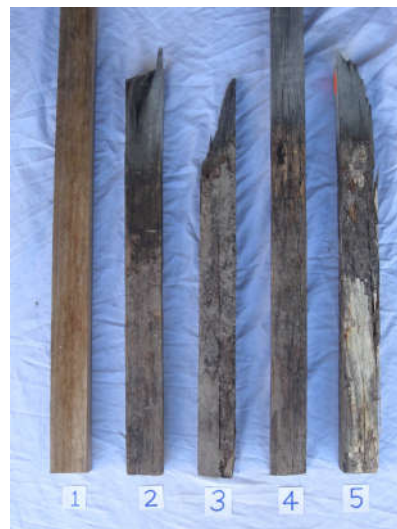
■ Vineyard 1

- Vineyard owner 1
288 *E. bosistoana* posts purchased in 2007 & 265 installed in new vineyard.
16 posts have broken which is 6% breakage.
4 broken posts fully excavated for further analysis.
- Vineyard owner 2
Purchased 69 *E. bosistoana* and 120 *E. globoidea* posts between 2006 – 2008 for replacements.
54 *E. bosistoana* and 110 *E. globoidea* posts found still in service.
This suggests 20%(?) breakage for *E. bosistoana* and 8.3% breakage for *E. globoidea*.
- Vineyard owner 3 (site with small feijoa orchard)
180 *E. globoidea* posts purchased in 2007.
161 posts installed in orchard with no breakages/replacements evident.

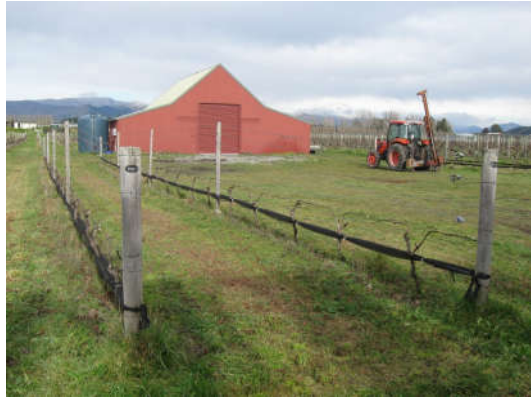
Vineyard 4

- Vineyard owner 4
120 *E. globoidea* posts purchased in 2009 and 90 *E. paniculata* posts in 2013.
All posts used as replacements across 3 vineyards.
All posts found in service except one reported broken last year by owner.
- Vineyard owner 5
308 posts purchased of various species from 2003 to 2009 for replacements.
All similar dimensions so unable to differentiate. 121 posts found in service in a 15 hectare section of 45 ha vineyard with another 32 posts in storage.
- Vineyard owner 6
149 *E. bosistoana* posts purchased in 2008.
Posts block stacked for 3 years before starting to use for replacements.
Uneven drying and cross grain resulted in some rejects before use.
37 posts found in service.

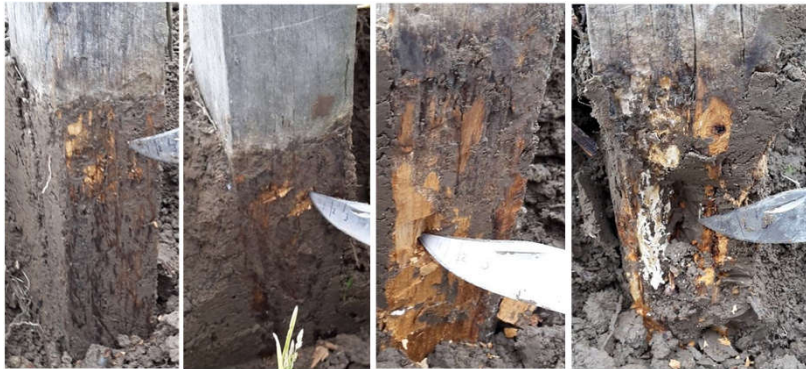
Range of decay in *E. bosistoana* posts

< 2mm

2-5 mm

10 -20 mm

> 30mm

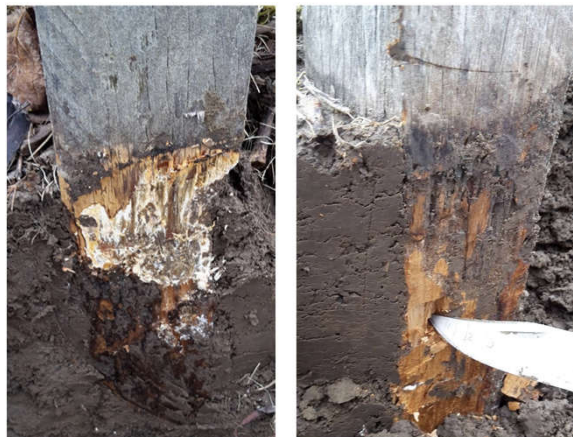
White-rot (left) and brown-rot (right) were found on posts of both species

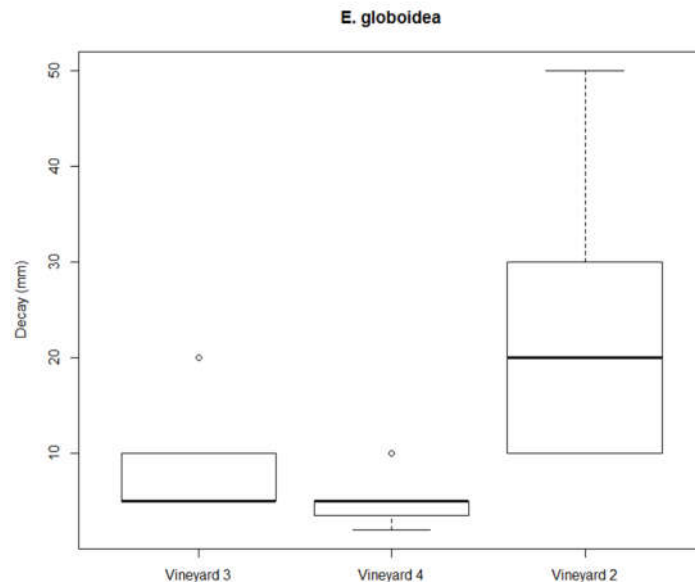
- *E. bosistoana* posts had less decay than *E. globoidea* posts after 8-10 years in service.
- Analysis confounded by site, as not all sites had posts of both species.
- *E. bosistoana* posts performed well at both assessed sites.
- Performance of *E. globoidea* was site specific. After 10 years several posts at vineyard 2 had severe decay while posts in the feijoa orchard had little decay. May be due to undervine cultivation at vineyard 2.

Vineyards 2 & 3 posts installed 10 years and Vineyard 4 posts installed 5 years
