## ROADLINE SALVAGE WITH AN EXCAVATOR LOG LOADER

Rob Prebble

### ABSTRACT

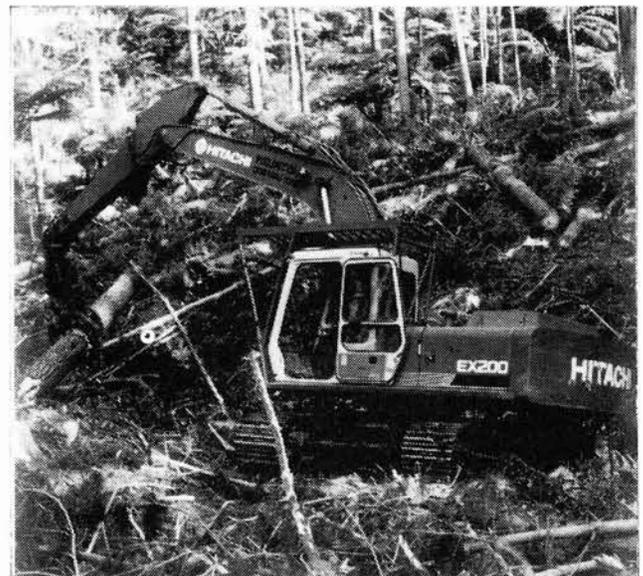
Figure 1 - The Hitachi EX200 used for Roadline Salvage

The Hitachi EX200 loader is a 20 tonne machine and it was not considered ideally suited to loader logging. It had a Prentice 8-48 grapple fitted to the standard excavator boom which limited the machine's reach. To correctly equip the Hitachi for loader logging it would have needed:

- (i) A purpose built logging boom to increase reach.
- (ii) A live heel to improve truck loading.
- (iii) Strengthening and guarding to the tracked undercarriage.
- (iv) A raised cab to improve operator visibility when loading.

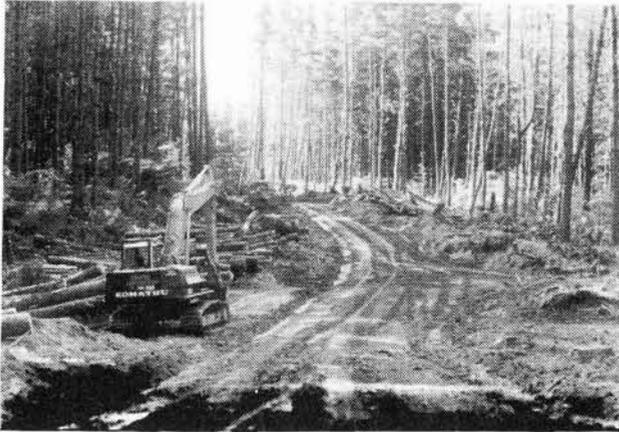
Figure 3 - The Roding Crew Move into Stump and Form the Road
