Task No: F20005 Milestone Number: 1.1.4 Report No. : H013

An evaluation of a ClimbMAX Steep Slope Harvester in Maungataniwha Forest, Hawkes Bay

Tony Evanson, Dzhamal Amishev, Richard Parker, Hunter Harrill

Date: 20 December 2013

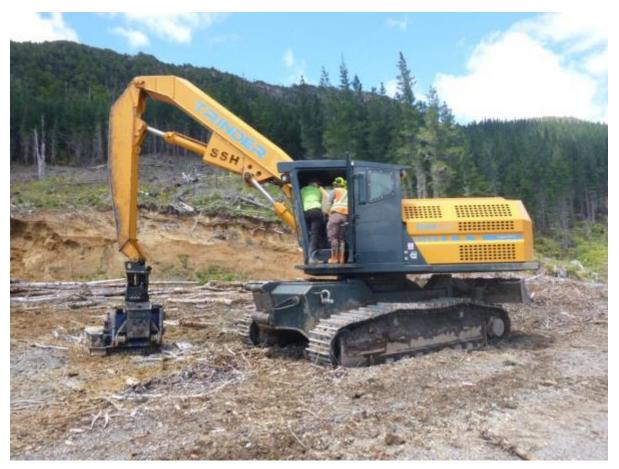
Figure 1: ClimbMAX2 Steep Slope Harvester

The ClimbMAX Steep Slope Harvester, designed by programme co-investors AW Trinder Ltd and Kelly Logging Ltd, with funding assistance from FFR, is now marketed by ClimbMAX Equipment Ltd. The ClimbMAX was designed to extend the range of ground-based machinery on steeper terrain, either for felling and bunching in a cable logging system or "shovel-logging" in a ground-based extraction system. With its integrated traction-assisted winch system, the ClimbMAX is capable of operating safely on steep slopes up to 45° on a range of soil types.

In early 2013 the first production machine (ClimbMax2) was studied during field testing in Marlborough ^[1] prior to delivery. The second evaluation of the ClimbMax 2 was undertaken in Maungataniwha Forest in Hawkes Bay, managed by Rayonier NZ Ltd (Figure 1).

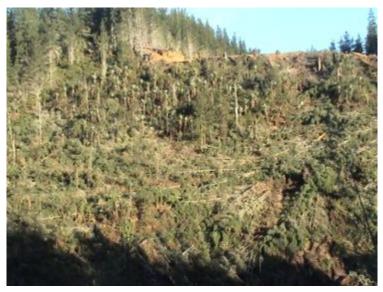
Figure 3: The trial site

The study area had an average tree size of 0.6 m^3 and a stocking of 745 stems per hectare (sph). The forest was in its first rotation converted from native forest (Figure 3). Slopes were convex in shape, ranging from 15 to 45 degrees and were up to 250m in length. The soil type on the site was well-drained (Drainage class 5) Sand (Placic Pan Podzols) with a depth range to a slowly permeable horizon of 0.45 - 0.89 m. At the time of felling, soil conditions on the site were wet, with isolated pockets of semi-swamp terraces.

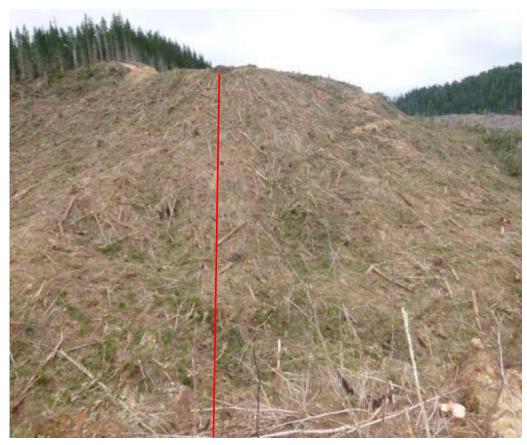
Figure 5: A view of the two sites assessed for site/soil disturbance: Area A (right) was felled by ClimbMAX; Area B (left) was manually felled.

In the Maungataniwha forest study, the ClimbMAX felled area was visually similar to the manually felled area (Figure 5).

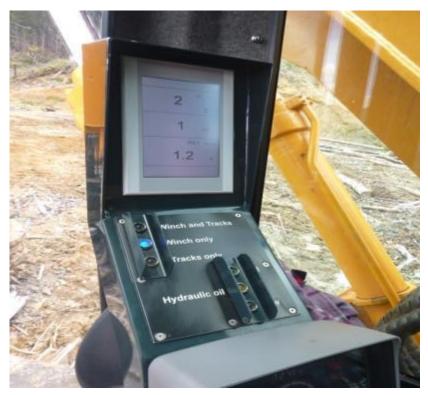
Figure 6: View from the cab and the winch/slope display.

- "The view is good from the cab. I can see the tracks and there is a window low down facing forward"
- "There is a roof window, with bars over it, so I can see enough of the trees above. But I normally plan two or three trees ahead and from that distance can see the whole tree through the front window"
