REPORT

Volume 24 No. 11 1999

Using Video to Improve Sweep Recognition in Mechanised Processing

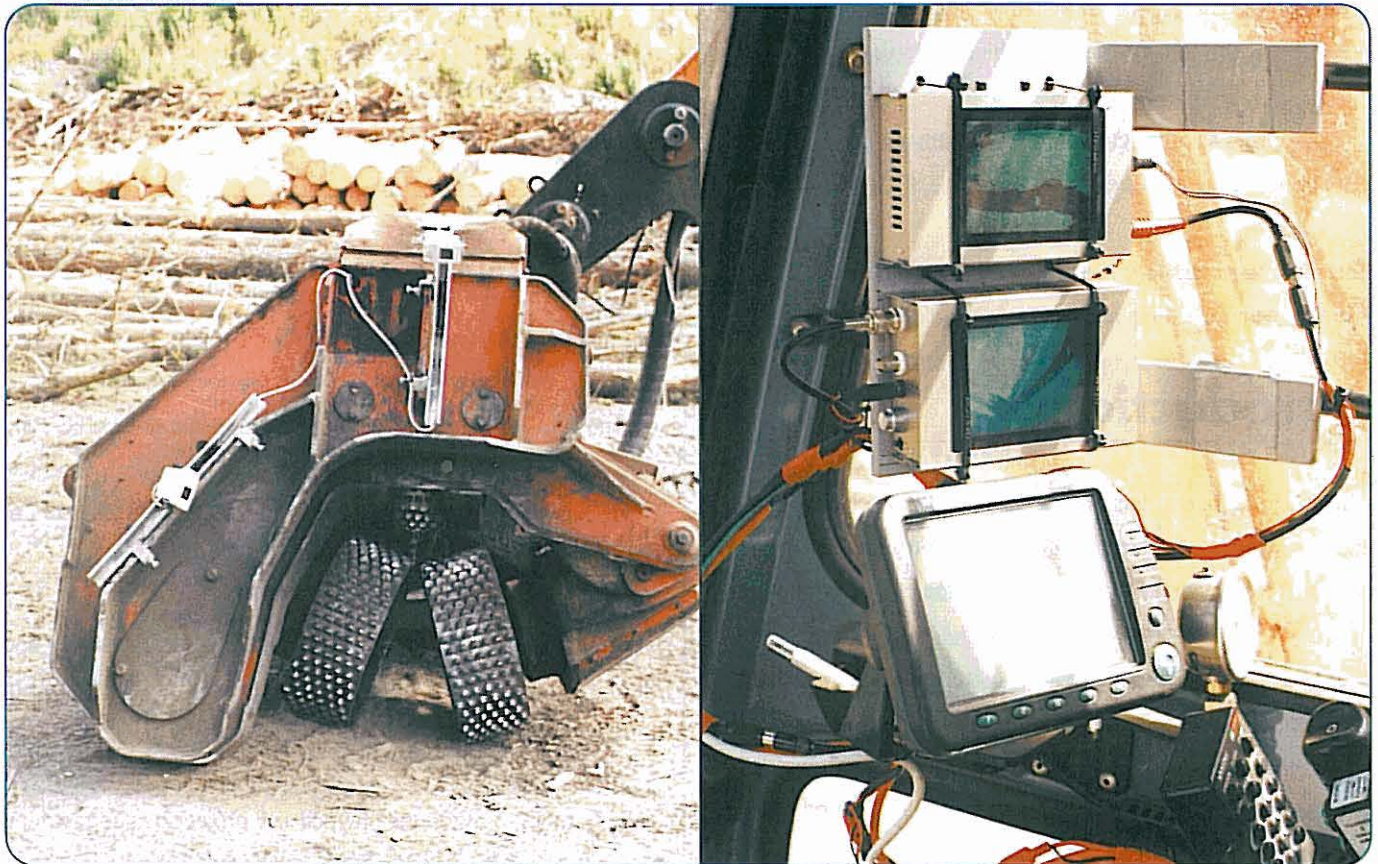
Figure 1 - Two cameras mounted on the harvester head. Images were displayed on two black and white screens within the machine cab

Waratah N.Z. Limited also helped the project by suggesting a suitable contractor/machine, and by making two camera-mounting brackets for a Waratah HTH 22 Super harvester head. They also helped with wiring the camera system.

The height above the centre of the log for the trialled camera was approximately 100cm. The mount was about 50mm in front of the log end as it exited the processor head.

Because of the use of a wide-angle lens (f2.8), the image in the monitor showed some distortion towards the edges of the viewed area. There was also some distortion of the log shape due to perspective. However, log sweep could be seen from changes in the straightness of the log's centre-line, and by the curve of the edges.

The results concern only the top-mount camera (showing horizontal sweep). The side-mount camera, showing vertical sweep, was damaged shortly after being fitted.
