POTENTIAL CAUSES OF TOWER COLLAPSES

Daniel Fraser
Dave Bennett

ABSTRACT

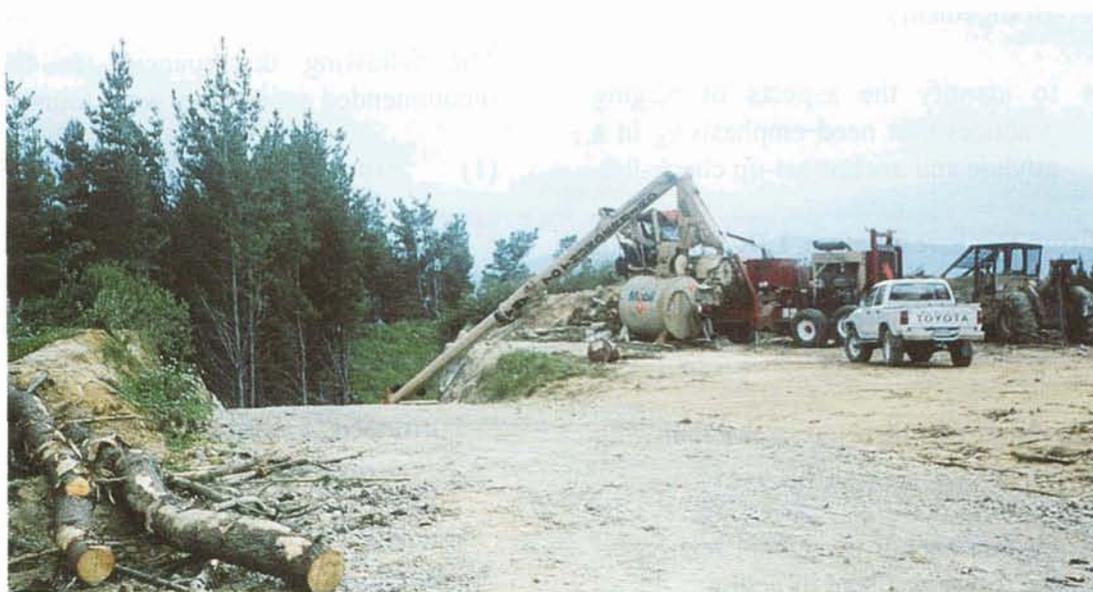
Figure 1 - Tower collapse because of inadequate guyline placement

The spacing of guylines will determine how evenly they share the loading and subsequently their overall effectiveness. Each model of hauler has instructions for positioning guylines. These instructions include limits of how the guylines must be spaced to ensure the maximum stability of the tower. The Safety Code for Bush Undertakings Part 2 - Cable Logging requirement is: "guylines shall be rigged in accordance with the manufacturer's instructions".
