AN EVALUATION OF A WARATAH HTH MODEL 234 FELLING AND TREE-LENGTH DELIMBING IN RADIATA PINE CLEARFELL

Mike McConchie
Tony Evanson

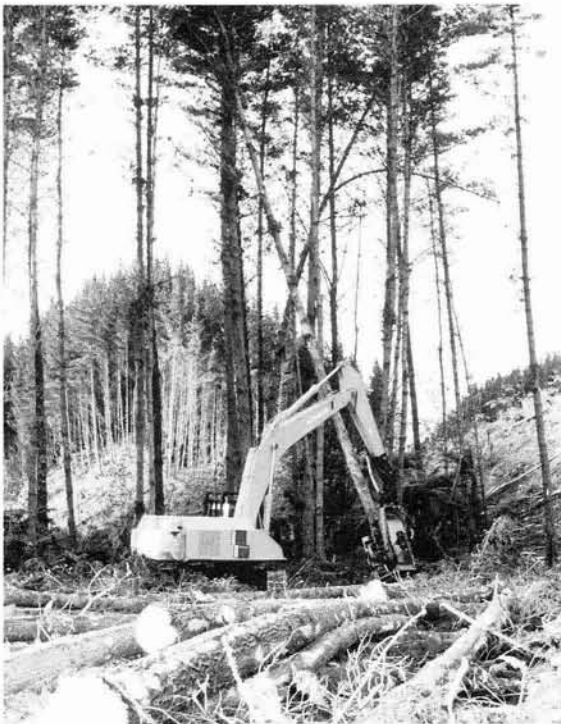
Figure 1 - Waratah 234 harvesting in Tarawera Forest

Work Method - The operator worked a swathe along the stand edge, felling trees predominantly into the stand forward of the machine (Figure 1). The operator preferred this technique as it crushed undergrowth and he believed it reduced overall tree breakage. Each tree was successively felled, delimbed on the right of the machine (for better visibility), and ejected. Tree-lengths were "bunched" in the form of a low continuous stack, which built up as the operation progressed. Sliding the logs along others enhanced delimbing.

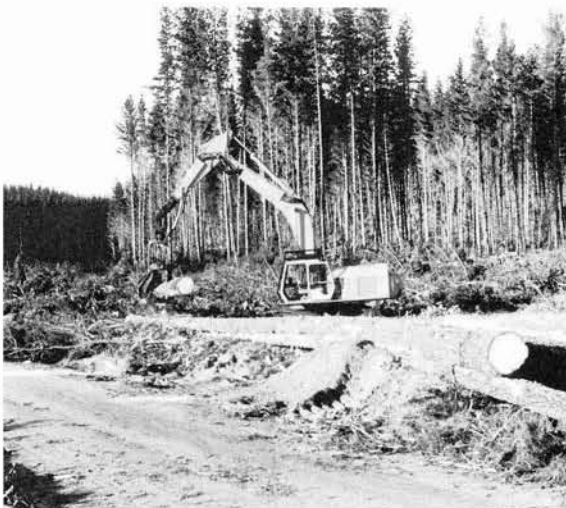
Figure 2 - Waratah 234 tree length delimbing in Tarawera Forest

Work Method - The operator approached from the butt-end, reaching and delimbing as many trees as possible from one location (Figure 2). Trees were delimbed and ejected on to low continuous stacks as above. Slovens, if they occurred, were cut prior to delimbing.

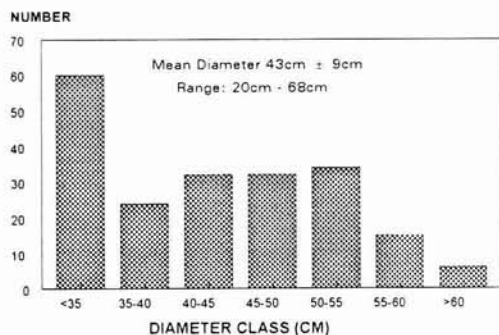
Figure 3 - Harvested trees

The Waratah 234 was timed to fell, tree-length delimb and "bunch" a total of 203 trees. A diameter distribution of the harvested trees is shown in Figure 3. Only four large trees (2%), were felled using the "double cut" method, to reduce possible felling related butt damage.

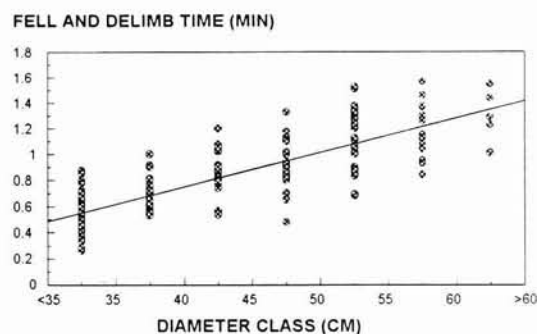
Figure 4 - Harvested trees

$$\text{Fell + delimb time (min)} = 0.0266 \times \text{DBH (cm)} - 0.3105 \quad r^2 = 0.65$$

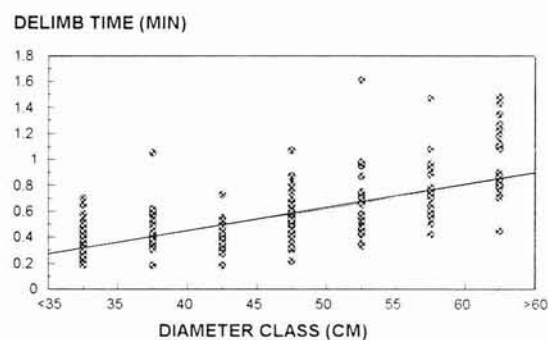
Figure 6 - Trees delimbed butt-first

$$\text{Delimb time (min)} = 0.0178 \times \text{DBH (cm)} - 0.2630 \quad r^2 = 0.41$$

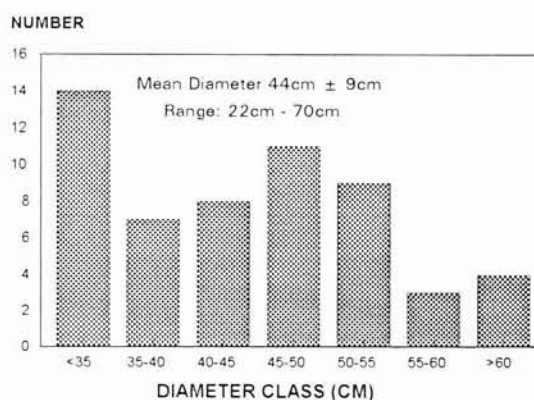
Figure 7 - Trees delimbed tip-first

The Waratah 234 was timed to delimb a total of 56 manually felled tree-lengths, beginning from the small/top end. A diameter distribution of the delimbed trees is shown in Figure 7.

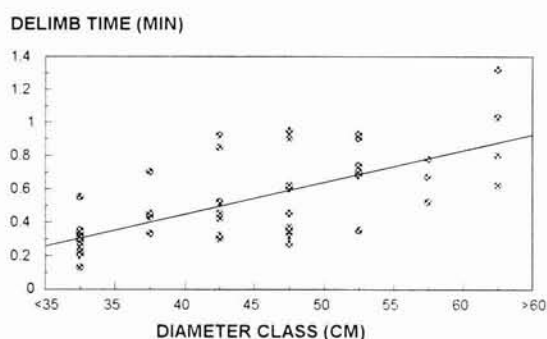
Figure 8 - Trees delimbed tip-first

$$\text{Delimb time (min)} = 0.0191 \times \text{DBH (cm)} - 0.3150 \quad r^2 = 0.48$$
