Productivity of the Active 70 Tower Yarder

Thornton Campbell, Hunter Harrill and Rien Visser
University of Canterbury, School of Forestry

HARVESTING TECHNICAL NOTE

HTN08-05
2016

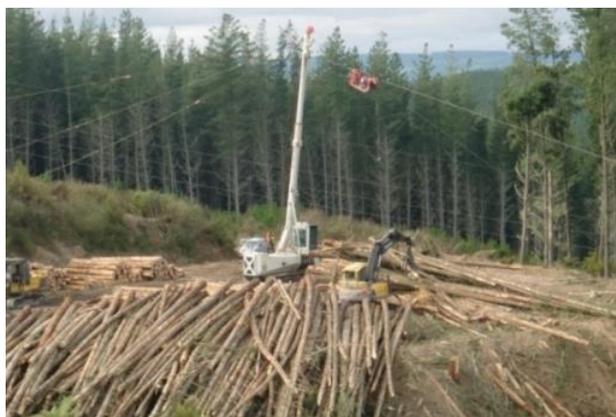
Figure 1: Active 70 yarder operating from the landing at the study site in Tahorakuri Forest.

Site One was located in Tahorakuri Forest managed by PF Olsen Ltd, 10 kilometres north of Taupo, New Zealand (Figure 1).

The forest was planted in 1987/88 and the area to be harvested had a stocking of 307 stems per hectare and a mean tree size of 2.2 m³ equating to 647 m³/ha. The study area was part of a larger harvest area of 20.2 hectares. The trial took place over five consecutive days from 15–19 June, 2015. The yarder was located on the same landing over this period, with one yarder shift and five line shifts recorded (Figure 1).

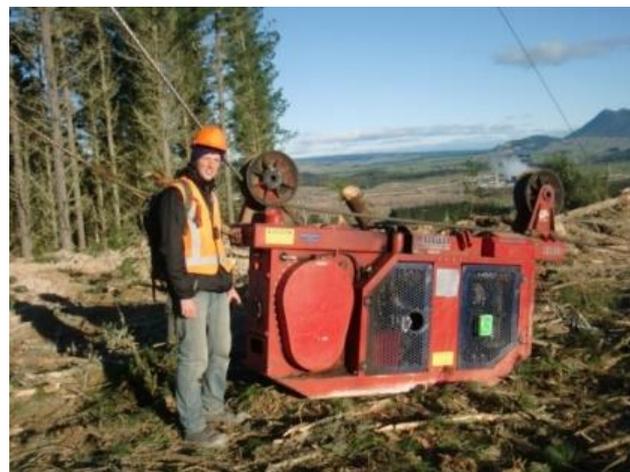
Figure 2: Boman Z7850 motorised carriage with radio controlled drop line.

Over the study period the yarder employed a standing skyline system using a Boman Z7850 motorised drop line carriage (Figure 2) operated in the shotgun (gravity return) rigging configuration. The carriage was equipped with three electronic chokers. Two breaker-outs were used to hook on stems. A 30-tonne excavator was used as a mobile tail hold and this facilitated fast line shifts. Weather conditions were mainly clear, with intermittent light showers and wind on two days of the study, but this was not considered significant enough to influence productivity results.

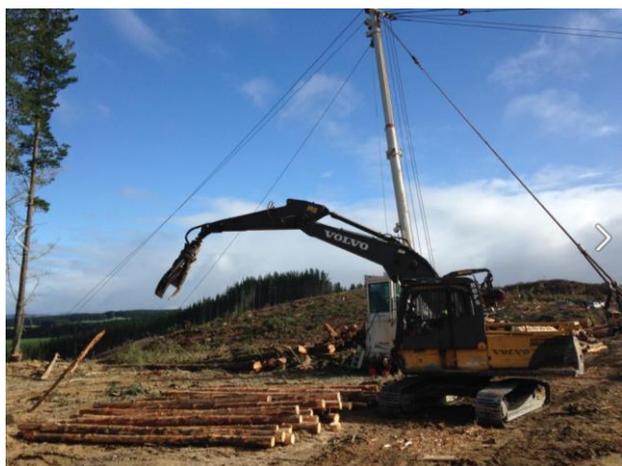
Figure 3: Operation close to where the noise measurement was carried out (decibel meter is located behind camera).

The noise monitor was also exposed to operational noise that occurred on the landing including chainsaws and large excavators (Figure 3). The additional sources of noise may have had an influence on the results, but due to averaging over eight hours per day this was expected to be of minimal influence.

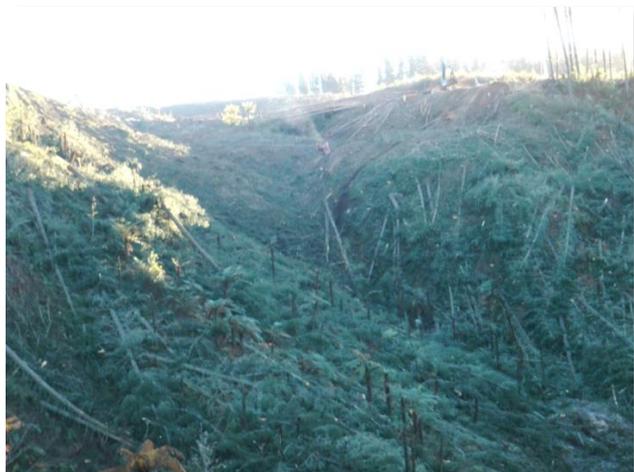
Figure 4: Example of steep and brushy terrain in which breaker-outs were working.

conditions can affect work rates, both sites were similar (Figure 4) and scored very similarly on the terrain and site assessment calculation and differences were deemed to be negligible.
