Constructex Wire Rope: Initial Trials

Hunter Harrill & Rien Visser
University of Canterbury, School of Forestry.

HARVESTING TECHNICAL NOTE

HTN08-08
2016

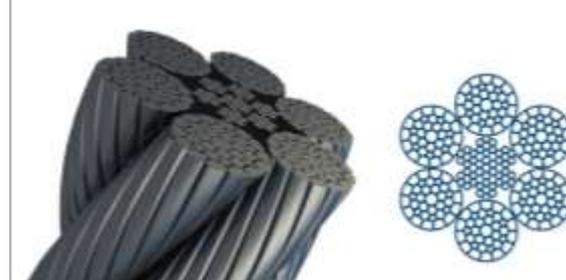
Dyforming is a process where a strand produced from round wires is passed through a die or rollers to squeeze the steel and compact the wires (Figure 2). The process increases the metallic area, like swaging, but creates a smoother contact surface between strands and wires within strands. These ropes have similar crush resistance and abrasion resistance to traditional swaged ropes but are known to have

improved resistance to bending fatigue due to the contact surfaces between wires (Simpson 1983).

Figure 2: Example of dyform wire rope marketed as Dyform 6 (courtesy of Cookes)

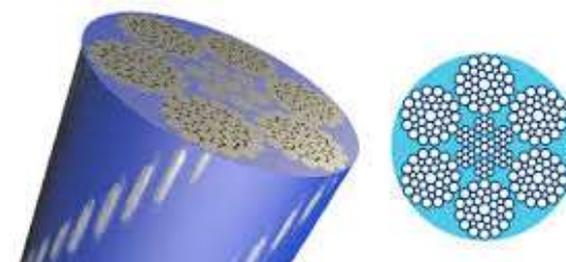
Plastic filled valley (PFV) ropes have thermo-plastic infused around the core and the individual strands (Figure 3). When closed, the plastic fills the valleys between the strands and the core, which effectively lubricates and minimises the internal friction. PFV ropes have exceptional resistance to bending fatigue compared to swaged ropes due to the plastic minimising contact stress between strands and wires (Shearer 1982; Simpson 1984).

Figure 3: Example of PFV wire rope marketed by Cookes as Brifill (courtesy of Cookes)

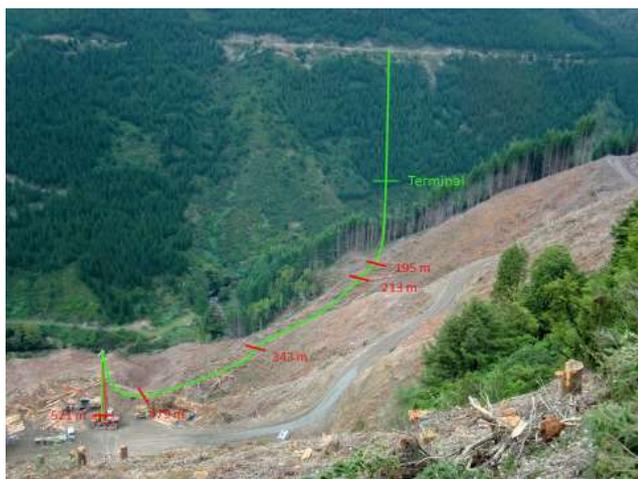
Every two months the rope was visually inspected at several points along the operating span of the skyline for deterioration due to wire breaks and corrosion, and the diameter was measured (Figure 6).

Figure 6: Example of inspection points along skyline span

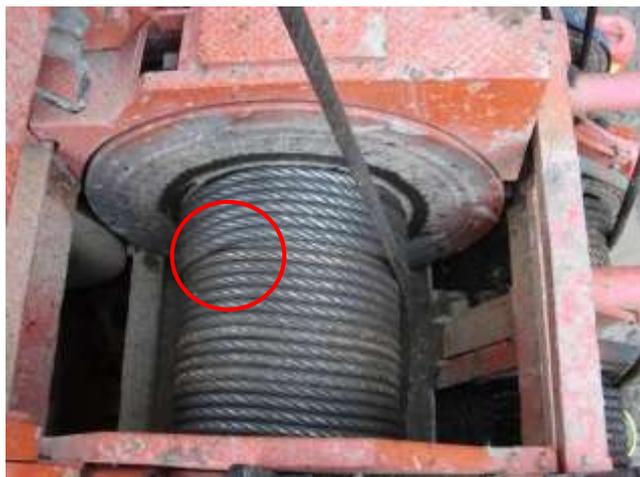
These wire breaks were located where a portion of the rope was spooling on and off the drum. The crew was aware of wire breaks in this location and associated the damage with cross-over points when spooling (Figure 8). Cross-over points are considered to be areas where accelerated wear by ISO standards is experienced.

The crew has experienced similar damage with other ropes resulting from cross-over points. Despite the severity due to fatigue from bending and reduction in

Figure 8: Example of cross-over points when spooling multiple layers onto drums.
