WIRE ROPE SPLICING METHODS

By G. S. Shields, Technical Services, Cookes Consolidated Services Ltd.

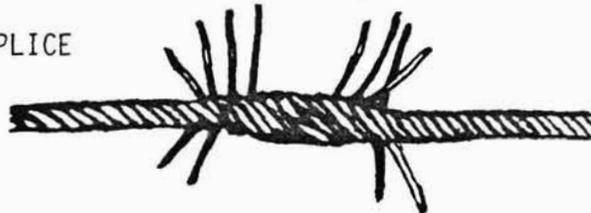
THE BUTT SPLICE

The butt splice is performed in such a manner that both splices run into each other, leaving in effect one splice. It should have a minimum of five tucks either side of the centre.

BUTT SPLICE: Performed well on tests to destruction and simulated working conditions. All samples broke at the end of the splice.

It is recommended that a butt splice be used in preference to a cut splice. Although both gave good results, the butt splice was consistently better. Finally, it should be remembered that any sort of splice creates a weakness in the rope through distortion, and as such should always be subjected to close inspection at all times.

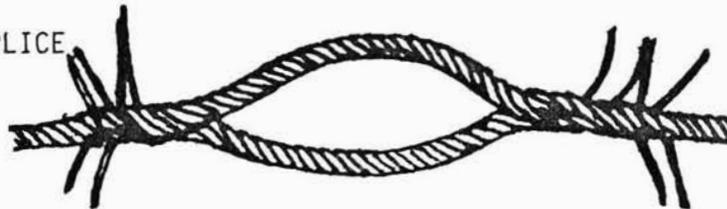
THE CUT SPLICE

The cut splice is two separate splices with a short length of each rope between them.

CUTT SPLICE: Also performed well on tests to destruction. The lower figures for the destruction test after working, were caused by inter-strand cutting in the double area of rope between the splices, which cabled up during the in-service tests. Test numbers 4 & 5 broke at the end of the splice, while test numbers 10, 11, 16, & 17 all failed in the area between the splices.

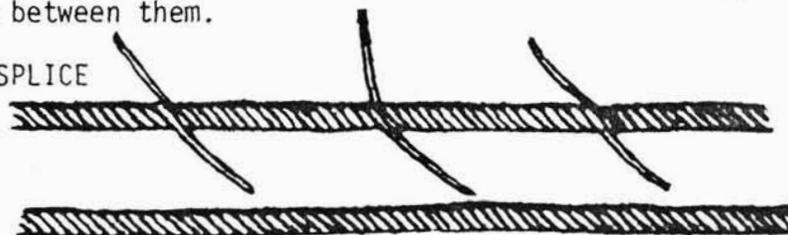
THE LONG SPLICE

The long splice is difficult to describe briefly. When finished, the rope where spliced, remains the same diameter as the main body of the remaining rope.

LONG SPLICE: The NZFP long splice was obviously well below standard for various reasons:

- the splice was only 5 metres long against a recommended minimum of 19.2 metres.
- the core of a rope represents 40% of the rope diameter and the strands 30%. The tails in the splice had not been straightened out when they were tucked inside to replace the straight core, and they were not built up to the original core diameter. Failure to do this causes the strands to collapse and creates a pig-tail effect in the rope.
- the cross overs at the marry points were not opened to mesh in and allow uniformity. These points were very bulky.
- there were no packers under the marry points.

A further disadvantage of the long splice for logging operations is the length of splice required (38.5 metres for a 32 mm rope). There is also the difficulty of finding a suitable area to perform the splice in the forest. It takes approximately one and a half days to perform this splice, against three hours for a butt splice. The rope is also weakened because the IWRC is removed. On lengths used for skylines and mainlines, the core creeps back from the tail ends leaving a section of rope with no internal support, and allows the strands to collapse and cut each other.
