# TECHNICAL NOTE TN-4

## CARBONFLO FUEL CONDITIONING DEVICE

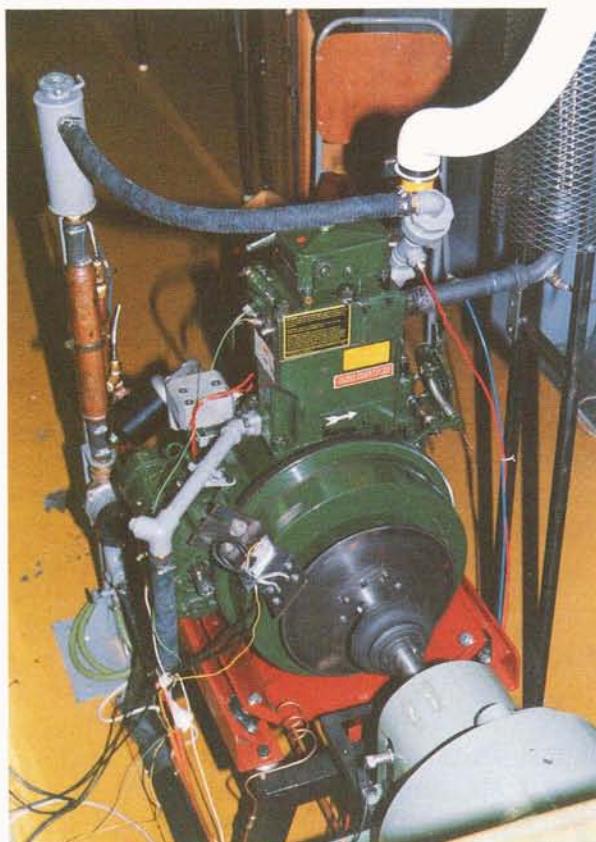
Figure 1 - The Lister Test Engine

The test engine was a water cooled Petter-Lister PHW1, a single cylinder direct injection diesel which had been mounted on a test bed and connected to an engine dynamometer. The engine was instrumented for combustion air and fuel flow rates, exhaust gas and inlet air temperatures, rpm and torque. The concentrations of oxygen and carbon monoxide in the exhaust were also measured.
