Stream recovery; Copper in waterways

Brenda R. Baillie, Anthony W. Evanson, Mark Kimberley, David Bergin, Diana Unsworth, Sunita Jeram

Date: 18th October 2017

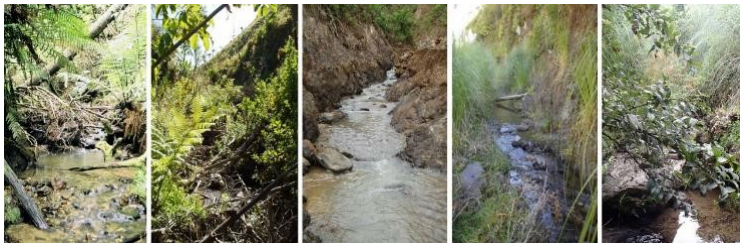
Riparian & stream water temperature

Pre-harvest 1 yr post harvest after event 3 yrs later 5 yrs later

- Stream temperature recovery closely linked to riparian vegetation recovery

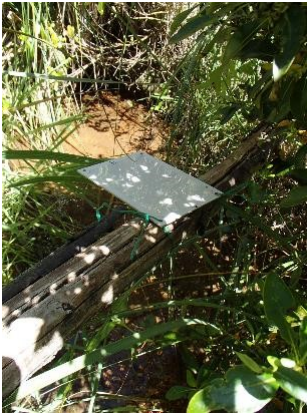
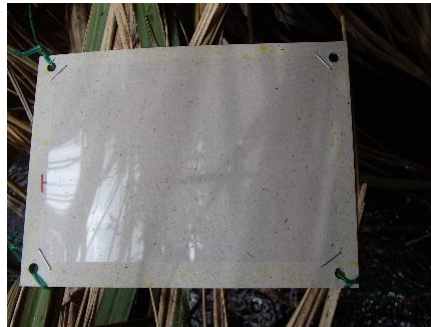
Monitoring

- Tracer plates were used to measure amount of copper reaching water surface
- Stream water and sediment were sampled for three months afterwards

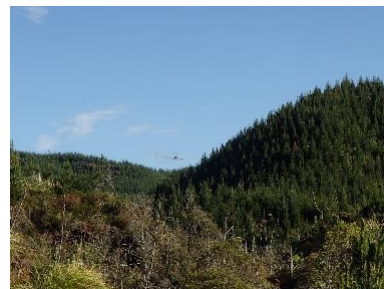
Copper in waterways results

- Copper was only detected for a few hours on the day of application
- NZ drinking water standards (2,000 ug L⁻¹) *not exceeded*
- FSC standard (LC₅₀ 18.9 ug L⁻¹ for 48 hours) – *concentrations exceeded the level but for less than 2 hours*
- ANZECC interim sediment quality guideline trigger values *not exceeded*
- Under today's operational conditions and technologies the risk to the aquatic environment from copper appears to be low for these sites
- Provides supportive data to FSC for continued operational use of copper in NZ's planted forests for Dothistroma and Red Needle Cast
- Supports industry Licence to Operate
