EROSION SOURCES AND SEDIMENT PATHWAYS TO STREAMS ASSOCIATED WITH FOREST HARVESTING ACTIVITIES IN NEW ZEALAND

Report: HAR H034

Prepared for the New Zealand Forest Owners Association

Project Final Report

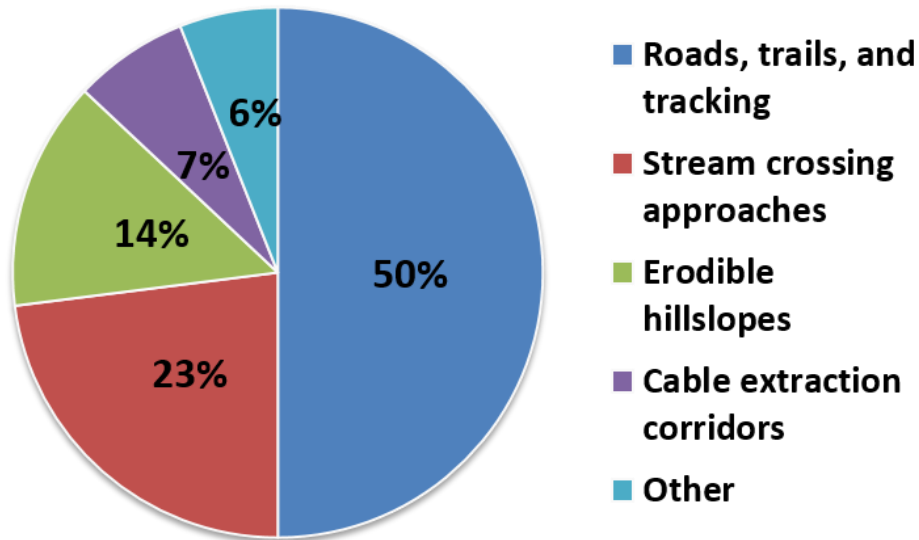
Figure 1. Breakthrough sources and their relative frequency. N = 53 for 'Roads, trails, and tracking', 24 for 'Stream crossing approaches', 15 for 'Erodeable hillslopes', 7 for 'Cable extraction corridors', and 6 for 'Other'.

Half of the breakthroughs found in this study were caused by concentrated runoff from roads, skid trails, or machine traffic disturbance on the hillslope (Figure 1). An additional 23% of breakthroughs occurred where roads and trails crossed streams. Thus, 73% of breakthroughs were associated with roads, trails, and machine tracks on the hillslope.

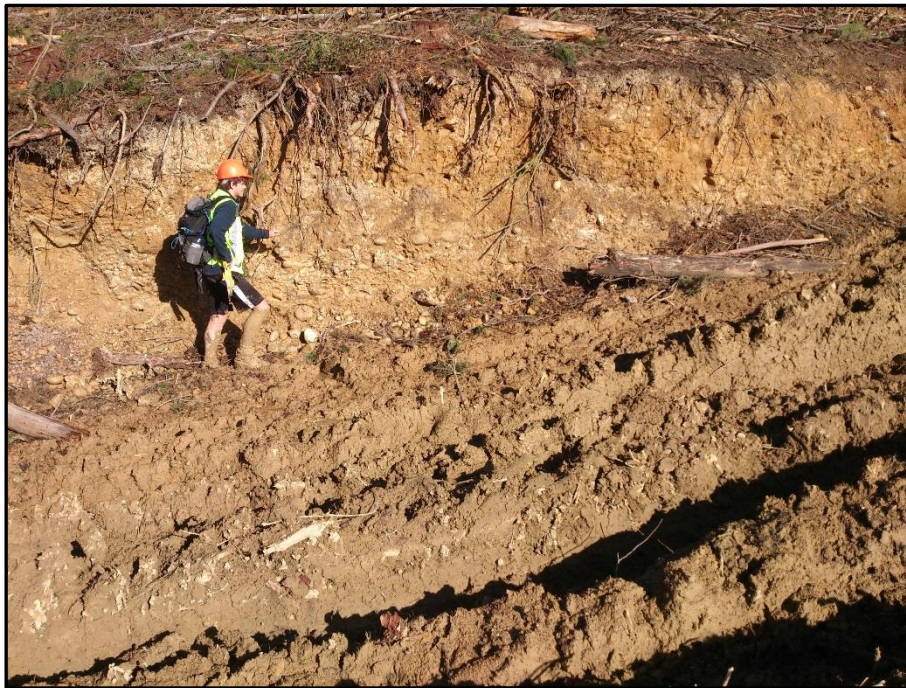
Figure 2. Photo depicting a badly rutted skid trail post-harvest. Photo: Kristopher Brown.

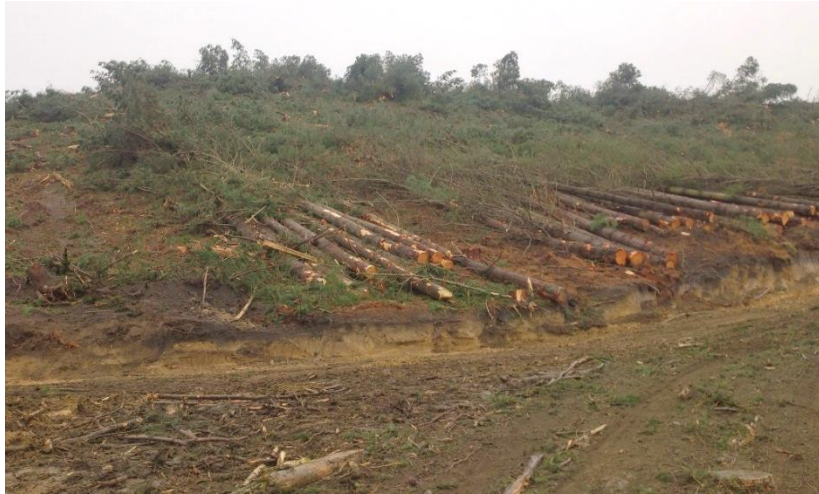
Figure 3. Bunched stems next to a skid trail awaiting extraction from a grapple skidder.

An example of minimising tracking associated with ground-based harvesting is to use shovel logging. Less tracking is required because stems can be shovelled to a skid trail and bunched in preparation for extraction (Figure 3).

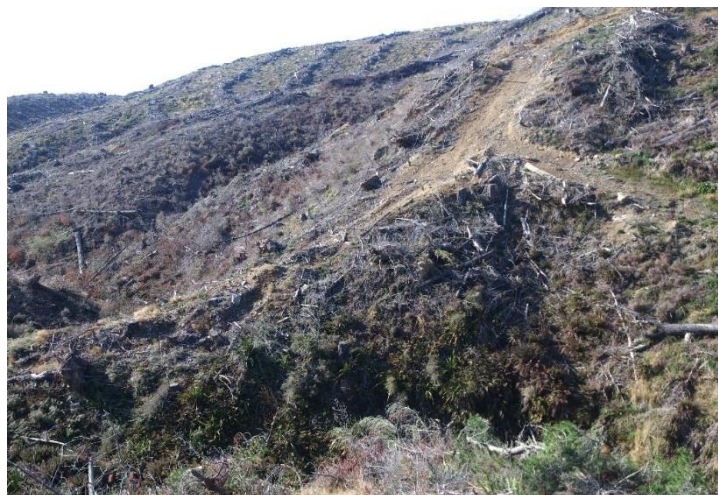
Figure 4. An example of a relatively steep ground-based harvest where skid trail disturbance was limited to ridge tops.

Further to careful road location and control of water erosion upslope, streamside management zones (SMZs) can provide a variety of protective functions, including sediment trapping, bank stability, shade (water temperature control), and food and habitat for aquatic organisms. Visser and Fenton (1994) provide a practical guide for forest managers to identify important values for streams and streamside areas, rank stream importance based on those values, determine an appropriate SMZ width, and prescribe SMZ requirements to protect the identified values. For example, even though harvesting of radiata pine may extend to the stream channel, minimizing machine traffic within a few meters of the stream can protect stream banks, while leaving some type of vegetative or slash barrier adjacent to the stream can aid in filtering surface runoff (Figure 4).

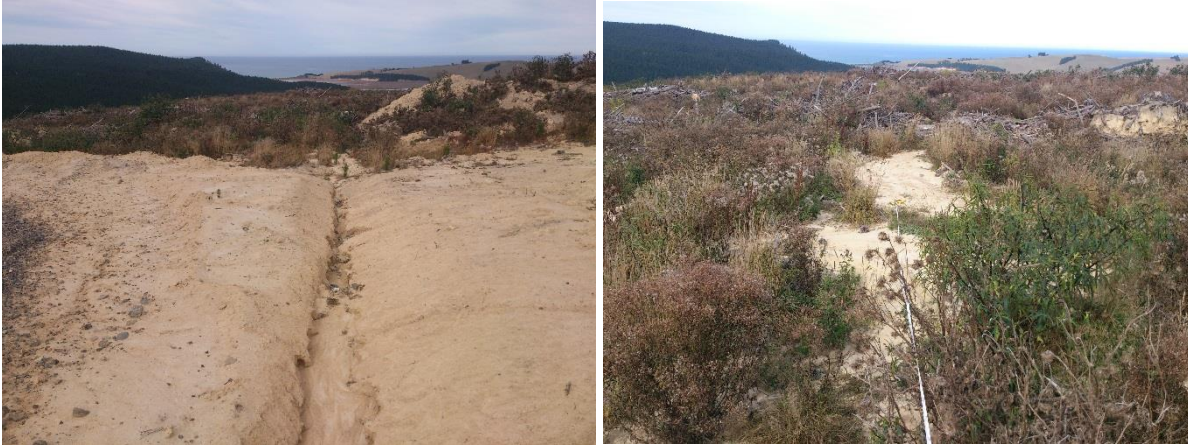
Figure 5. Left: At a road curve, a cut-out moves water from the ditch into an area in the cut-over with flat topography and high surface roughness, ideal for trapping sediment. Right: Sediment is trapped and stored in the cut-over.

comes to road surface runoff, think “Slow it down and spread it out” (Figure 5). This can be achieved by spacing water control structures (e.g. cross-drain culverts, cut-outs, or water bars) according to road gradient and soil erodibility. As road gradient or soil erodibility increases, road drainage structures need to be spaced at shorter intervals.

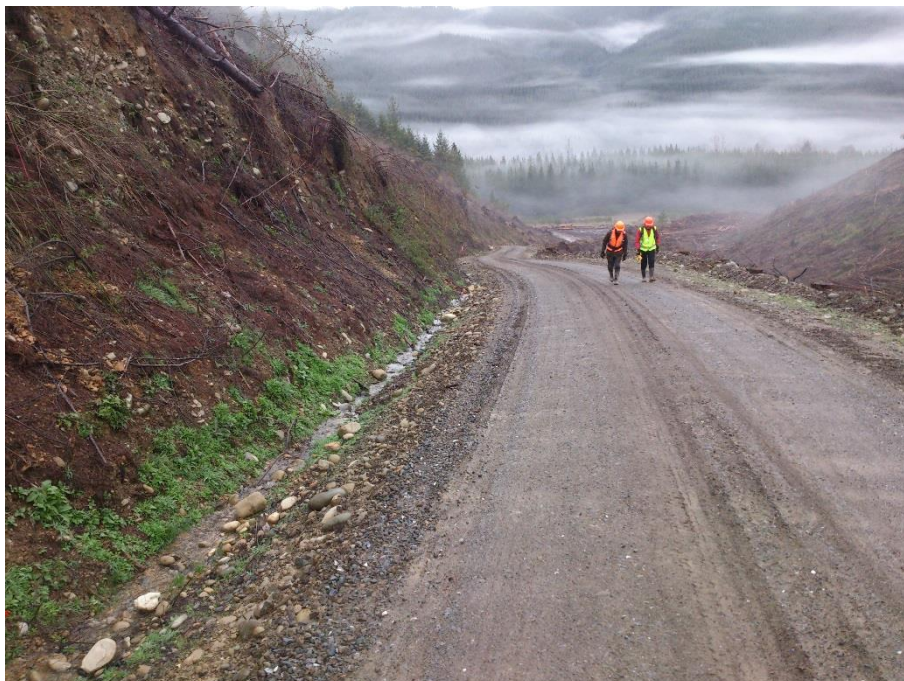
Figure 6. A secondary forest road with a good shape (crown), which moves half of the road surface runoff to the inside ditch and half to the fillslope (outer) side of the road. Water in the ditch drains to a series of cross-drain culverts, while surface runoff from the outer half of the road is relieved by a series of cut-outs. Note that the ditch also concentrates subsurface flow from the hillslope above the road, which may have a much larger catchment area than that of the road surface itself. The spacing of road drainage structures needs to take this into account.

In addition to appropriate spacing of road drainage structures, the shape of the road profile is important for reducing runoff volume and velocity. For example, a crowned road sheds half of the road surface runoff to the inner and half to the outer sides of the road. (Figure 6).

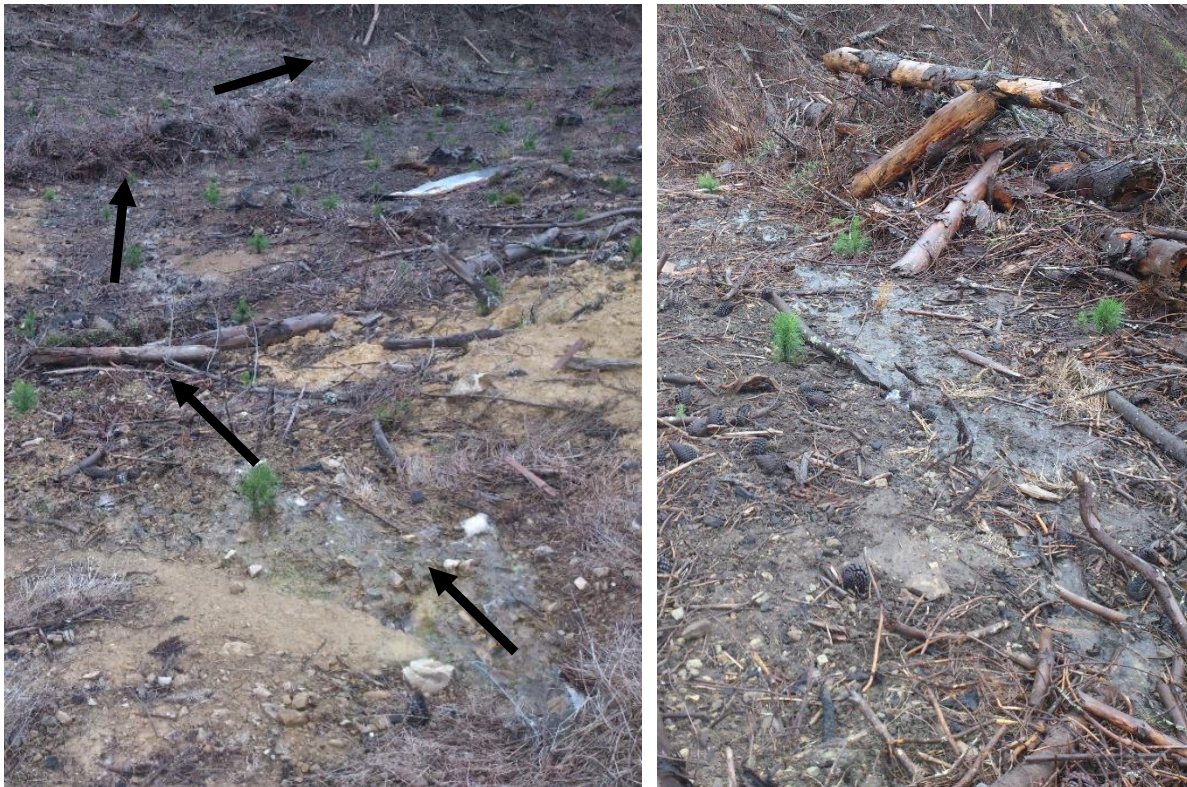
Figure 7. Left: Runoff flowpath on the hillslope below a cross-drain culvert. The slope is moderately steep (21 degrees) and surface cover is low after root raking and replanting, but surface runoff must travel 95 meters on the hillslope and pass through a slash windrow on its way to the stream. Right: Concentrated surface runoff reaches the stream, but it is flowing clean.

Locating road drainage structures to avoid discharging surface runoff directly or indirectly (e.g. through ephemeral gullies) to stream channels is also important to reduce road-to-stream hydrologic connectivity. A cut-over with an intact forest floor is a good example of a desirable receiving environment because its stability, roughness, and high infiltration capacity improve infiltration of runoff and trapping of sediment. Other desirable characteristics for receiving environments include gentle slopes, lack of convergence, and some distance between the drainage outlet and the stream (Figure 7).

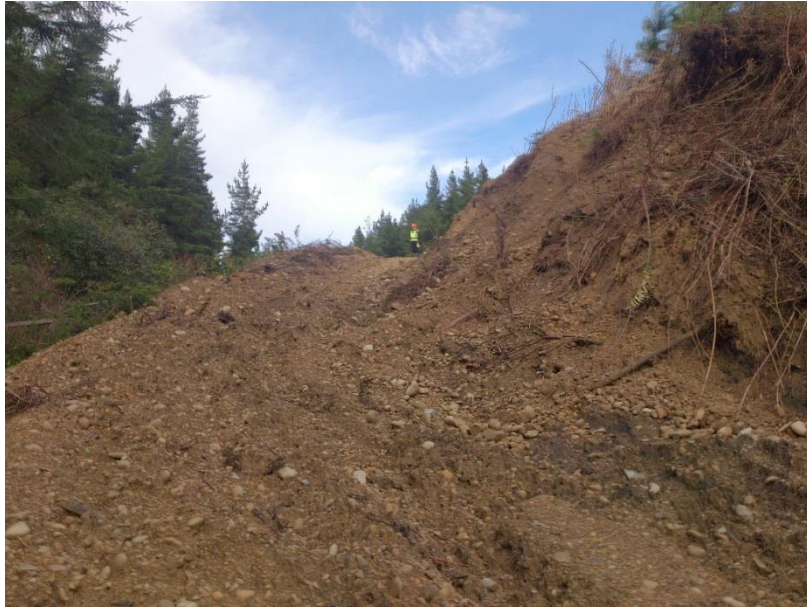
Figure 8. This temporary stream crossing approach was steep (33% slope), with no water control, and poor surface cover (20% cover). The potential erosion rate was estimated at 204 tonnes/hectare/year.

While just 10 of 35 skid trail approaches to stream crossings contributed to sediment breakthroughs in this study, the ones that lead to breakthroughs did so in a big way (Figure 8). For example, the median potential erosion rate for skid trail approaches that led to breakthroughs was 71 tonnes/hectare/year versus 1.6 tonnes/hectare/year for the surfaces of log truck roads. Closure of bladed trails at stream crossings should include drainage structures, such as water bars, plus some type of surface cover (Figure 9).

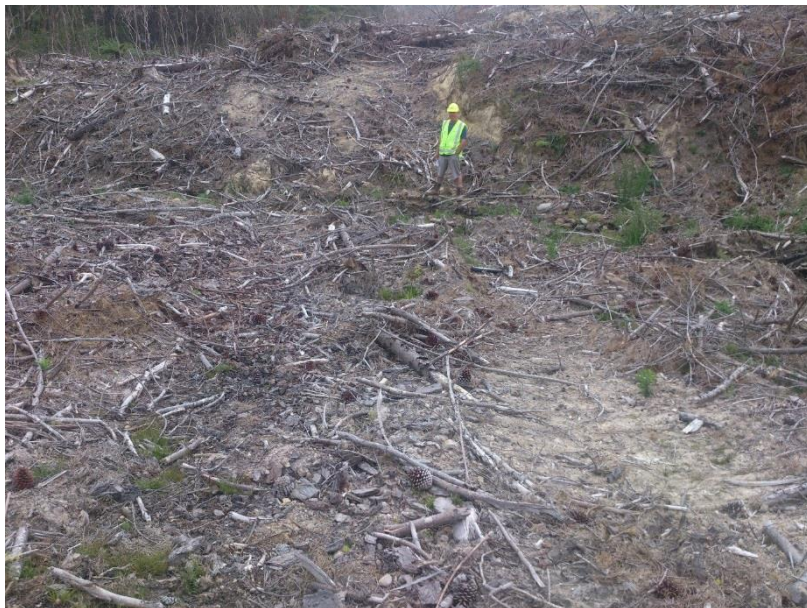
Figure 9. This temporary crossing has gentle approaches to the stream, slash barriers were used to disrupt concentrated surface runoff, and logging slash was used to provide surface cover.

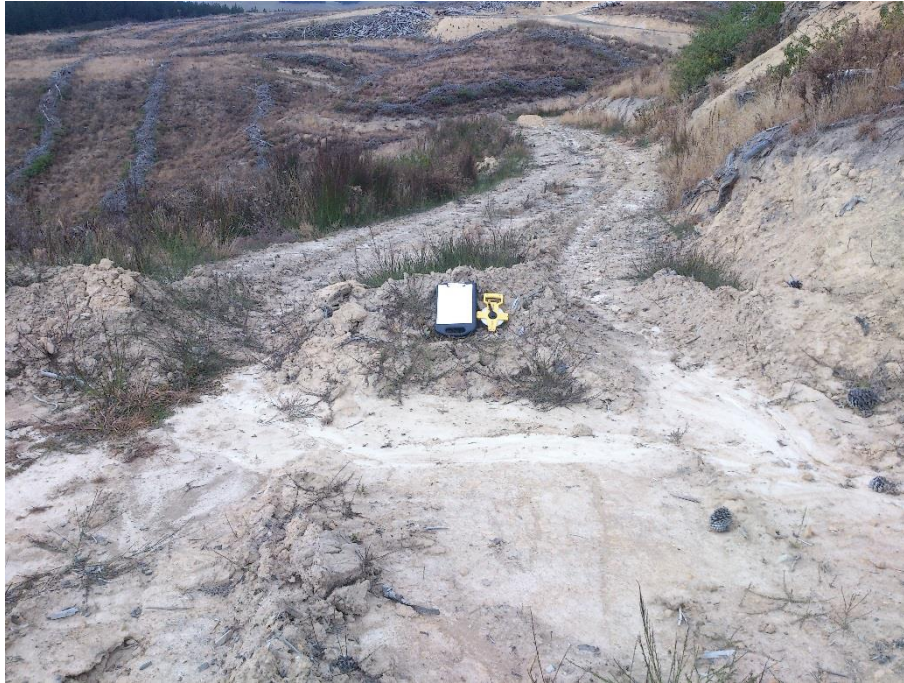
Figure 10. Surface runoff passes through this water bar because it has been compromised by traffic.

For skid trails and other temporary tracks, water bars, cut-outs, and other erosion control practices need to function for about two years post-harvest (Figure 10). By then, harvested sites have revegetated and exposed soil has become less erodible (i.e. easily transported sediment has been

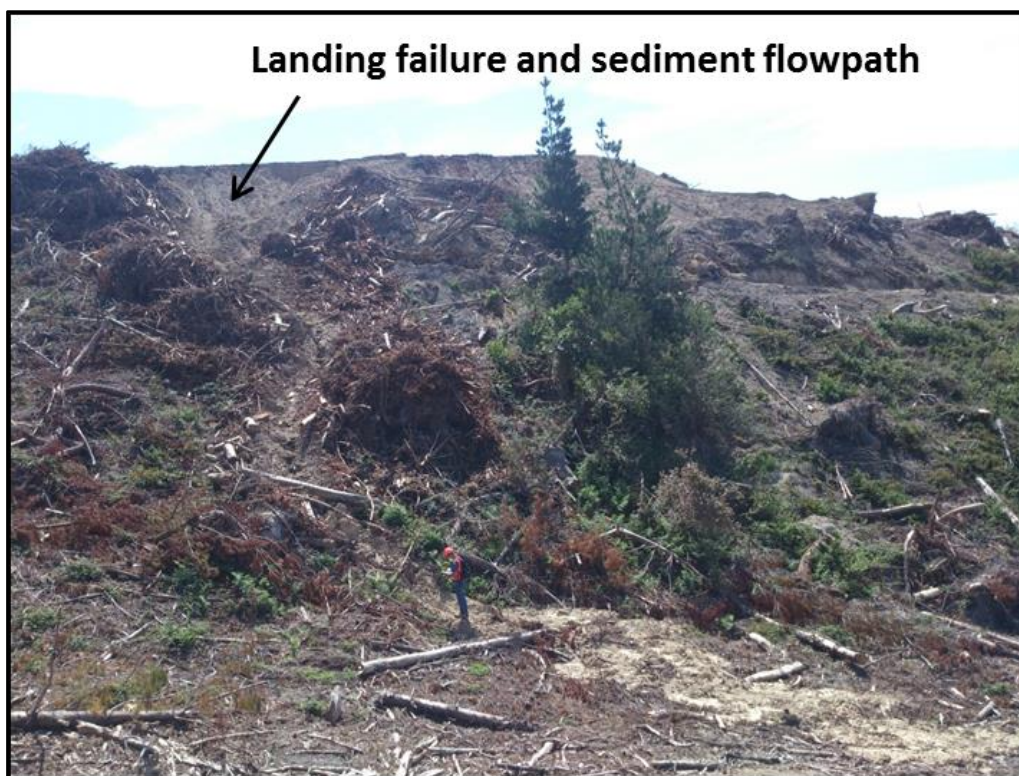
Figure 1. Example of a sediment breakthrough to an ephemeral stream channel. This breakthrough resulted from a landing failure. Photo: Kristopher Brown.

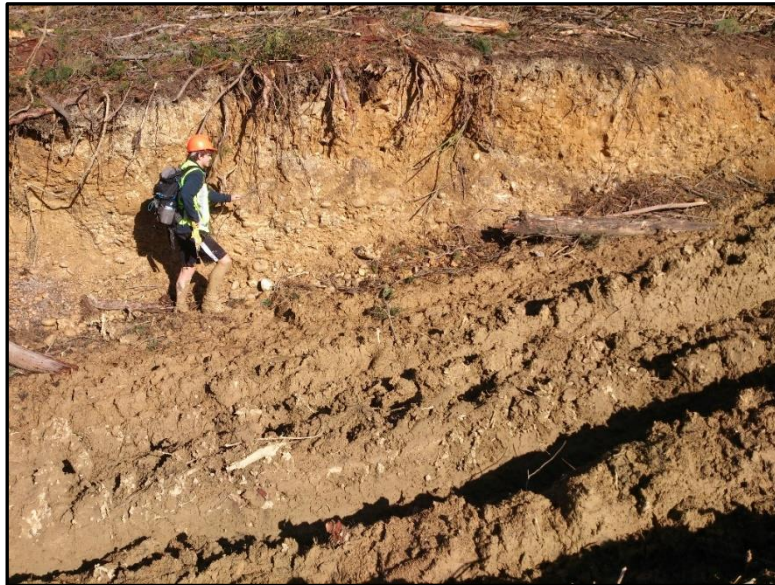
Figure 2. Photo depicting a badly rutted skid trail post-harvest. Photo: Kristopher Brown.

Two ground-based harvests accounted for 35% of all breakthroughs, suggesting that forest harvesting does not result in ubiquitous sediment inputs, but that one or more ‘problem’ sites could dominate downstream water quality impacts. At one of these sites, five breakthroughs resulted from surface runoff and fill slope slumps from a truck road and associated stream crossing constructed in highly erodible silty loam soils. An additional 10 breakthroughs resulted from naturally-occurring erosion features (i.e., many small land slips, rills and one gully) with no obvious connections to harvesting or road construction activities. At the other problem site, most of the breakthroughs were associated with deep rutting from skid trails and machine traffic near the stream with no provisioning of surface cover during site closure (Figure 2).

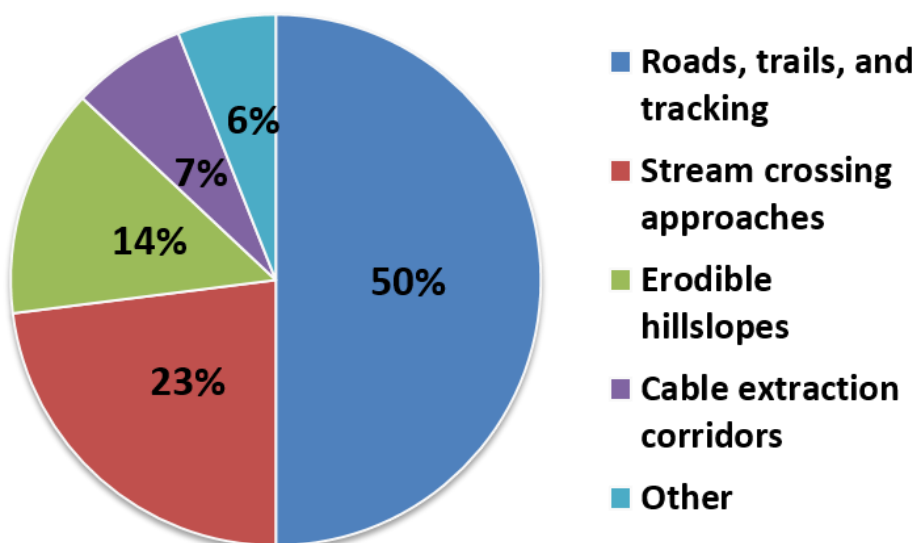
Figure 3. Breakthrough sources and their relative frequency. N = 53 for 'Roads, trails, and tracking', 24 for 'Stream crossing approaches', 15 for 'Erodible hillslopes', 7 for 'Cable extraction corridors', and 6 for 'Other'.

Most breakthroughs (50%) were caused by concentrated runoff from roads, skid trails, or machine traffic disturbance on the hillslope (Figure 3). An additional 23% of breakthroughs occurred where roads and skid trails crossed streams. Thus, 73% of breakthroughs were associated with roads, trails, and machine tracks on the hillslope. These findings reinforce the importance of pre-harvest planning efforts to minimise earthworks, locate roads and stream crossings to avoid steep gradients, and maintain a buffer (e.g., an SMZ or slash barrier) between disturbed soil and streams. Such practices should reduce the occurrence of road-related sediment breakthroughs and reduce the severity of impacts to water quality. Furthermore, road-stream crossings represent easy targets that can be identified during the planning stage and BMPs can be prescribed for water and erosion control.

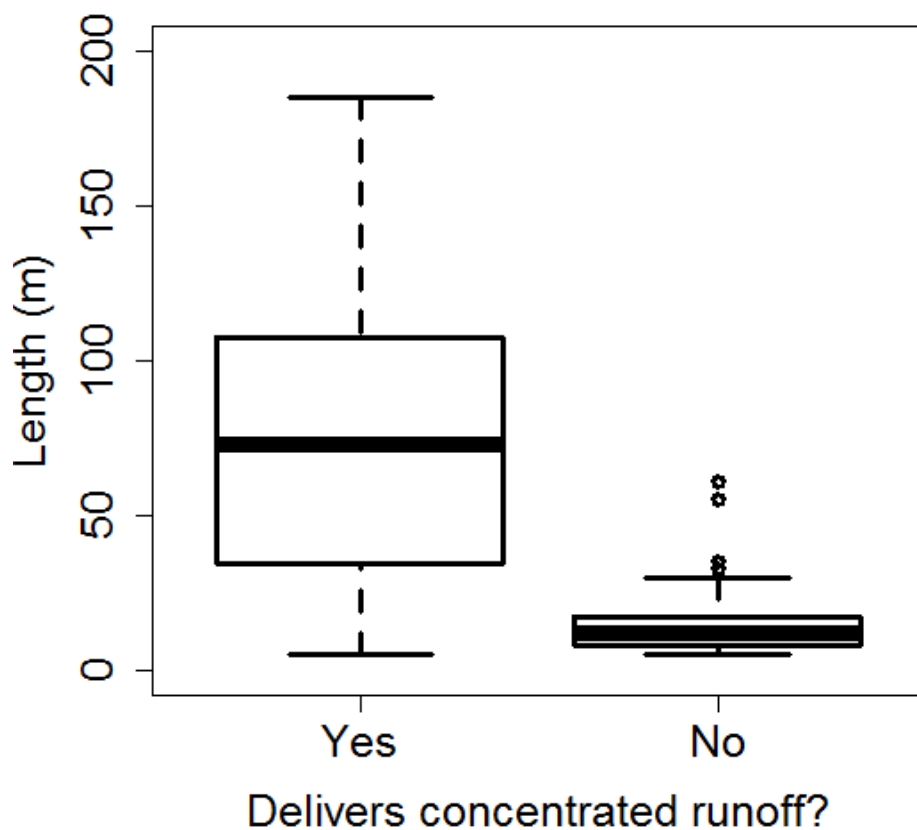
Figure 4. Box and whisker plots (showing the 5th, 25th, 50th, 75th, and 95th percentiles) of stream crossing approach length (m) in relation to whether or not the approach delivered concentrated surface runoff to the stream (n = 27 for ‘Yes’ and n = 29 for ‘No’). Approach length was defined as the distance from the stream to the nearest road drainage structure (e.g. water bar, turnout, or culvert cross-drain) or topographic feature that moved surface runoff away from the road.

The distance from the stream to the nearest water control structure was important for understanding road-to-stream hydrologic connectivity. Median drainage length for road-stream crossings that led to breakthroughs was 73 m, ranging from 5 to 185 m (Figure 4). Conversely, median drainage length for road-stream crossings that did not lead to breakthroughs was 12 m, ranging from 5 to 61 m. These findings suggest that while it may be difficult to eliminate connectivity from log truck roads at stream crossings (due to their inherently compact design), the severity of water quality impacts can be managed by adding water control structures to reduce the drainage length. Sessions (2007) recommended reducing the drainage length at road-stream crossings to approximately 20 m. Of the 21 truck road approaches to stream crossings measured in this study, only 4 had a drainage structure within 20 m of the stream. For skid trail crossings, connectivity could be reduced by using overland (not bladed) skid trails where slope steepness allows, as well as installing cut-outs for water control and using slash or mulch for surface cover during road closure.

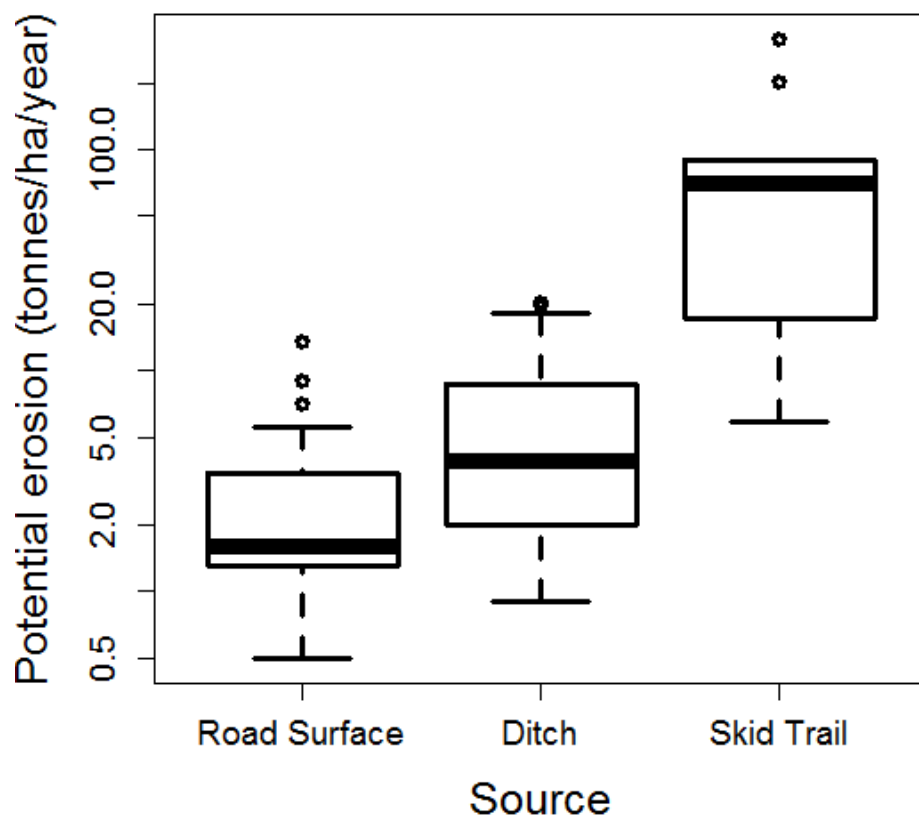
Figure 5. Box and whisker plots (showing the 5th, 25th, 50th, 75th, and 95th percentiles) of potential erosion rates of log truck and skid trail stream-crossing approaches (n = 17, 14, and 10, respectively, for truck road surfaces, truck road ditches, and skid trails). Each of these approaches contributed to a breakthrough.

Erosion estimates ranged from 0.5 to 13.4 tonnes/ha/yr for truck road surfaces, 0.9 to 20.1 tonnes/ha/yr for truck road ditches, and 5.9 to 314.8 tonnes/ha/yr for skid trail surfaces (Table 2). The median potential erosion rate for skid trails was 44 times greater than truck road surfaces and 18 times greater than truck road ditches (Figure 5) because skid trails that led to breakthroughs were steep (median = 16.5% slope) with 0 to 30% surface cover. This finding highlights the importance of closing skid trails properly, especially at stream crossings. Several studies have demonstrated the sediment-reduction efficacy of skid trail closure techniques, such as water bar installation, plus slash or mulch application (Sawyers, Bolding, Aust, and Lakel 2012, Wade, Bolding, Aust, and Lakel 2012, Vinson 2016).

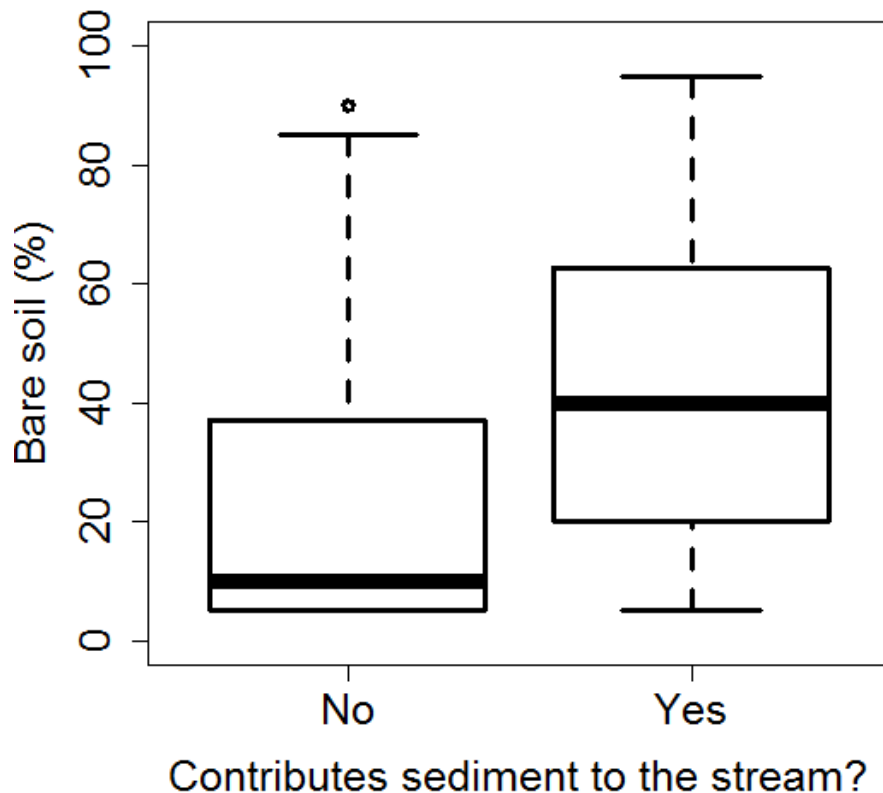
Figure 6. Box and whisker plots (showing the 5th, 25th, 50th, 75th, and 95th percentiles) of bare soil percentage for upslope contributing areas that did ($n = 77$) and did not ($n = 267$) lead to a breakthrough.

Excluding stream crossing approaches, breakthrough likelihood of occurrence increased with increasing bare soil percentage ($Z=5.2$, $p<0.001$) (Figure 6). Hillslopes with no roads, skid trails, or machine traffic disturbance ($Z=-2.4$, $p=0.02$) or only machine traffic disturbance ($Z=-2.8$, $p=0.004$) decreased the likelihood of a breakthrough. Median bare soil percentage for upslope areas contributing to breakthroughs (40%) was 4 times higher than that of those that did not (10% bare soil).
