Report No.: H039

Productivity and utilisation of winch-assist machines: case studies in New Zealand and Canada

**Cameron Leslie, University of Canterbury
and
Colin Koszman, FPIInnovations, Canada**

Date: 11 July 2019

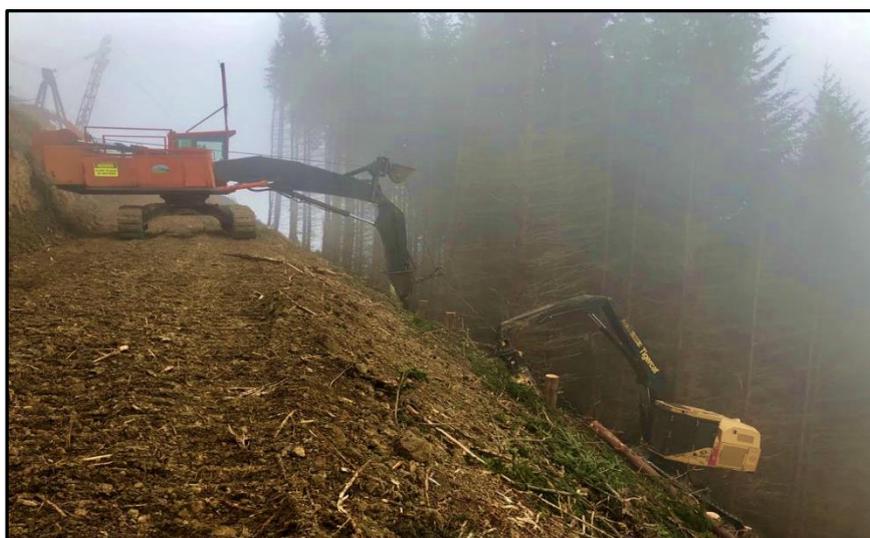
The harvesting contractor was Button Logging Ltd, a local contractor in the region, and having two crews contracting to Rayonier Matariki Forests. The winch was mounted on a Hitachi Zaxis excavator, and was one of six machines constructed by Waka Welding Ltd of Waikouaiti, Otago. The felling machine was a Tigercat LS855D tracked feller buncher with a Tigercat 5195 directional felling saw (Figure 1).

Figure 1. Waka Welding Ltd winch-assist and Tigercat LS855D: Case Study 1

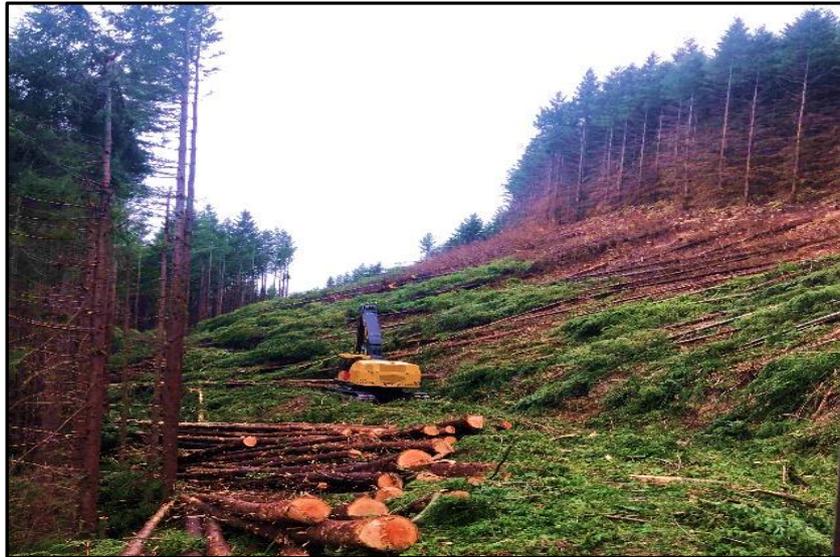
Figure 3. Shovelling along a skid trail
(Note: feller-buncher not attached to anchor machine).

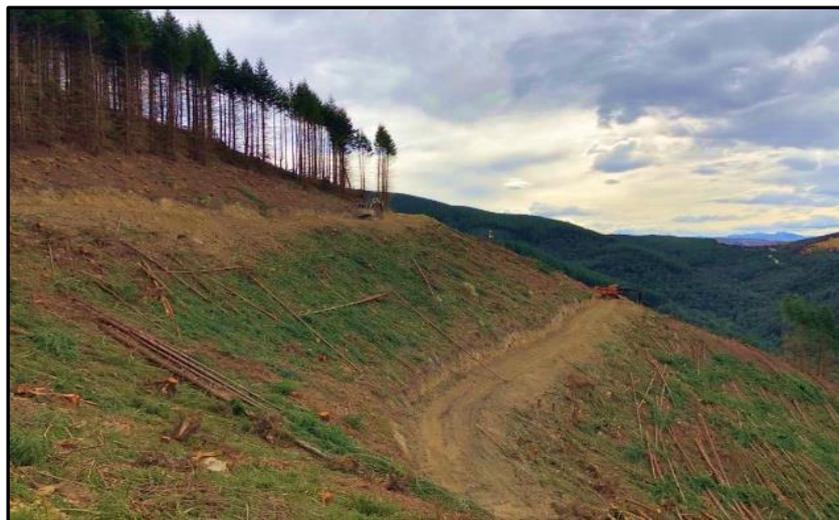
The operator stated that having a second track above the tree face or having the ability to position the anchor machine well above the tree face would decrease operational delay. A second track increases the area able to be harvested before moving the anchor machine. An example of a second track can be seen in Figure 4. It was noted that the main purpose of this track was for access to provide access for the swing yarder tail hold machine (Figure 5).

Figure 5. Second track that could be used for the anchor machine (Case Study 1)

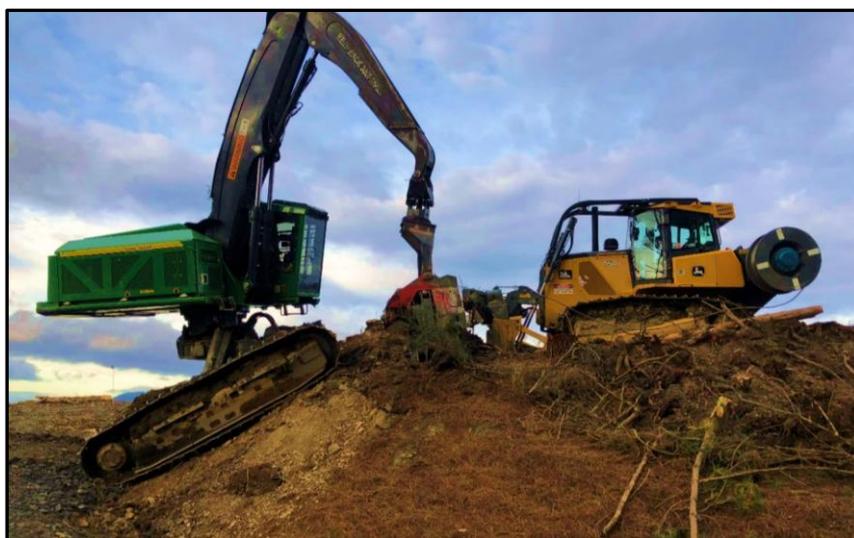
The harvesting contractor was a resident in the area, with a long-term family relationship of at least 30 years with City Forests Ltd, the forest management company. The winch-assist machine was a Remote Operated Bulldozer (ROB) manufactured by Rosewarne & May Ltd in Whangarei, based on a John Deere 850 bulldozer. The felling machine was a John Deere 909MH feller buncher with a Woodsman Pro FH1350 directional felling saw (Figure 6).

Figure 6. ROB winch-assist and John Deere 909MH: Case Study 2

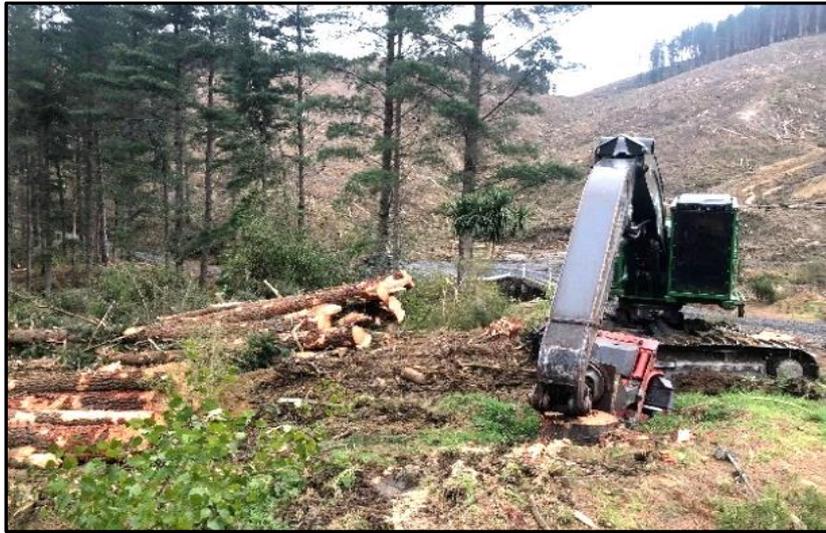
Shovelling (14%) took place when the harvested area was not visible to the swing yarder operator and when falling beside the stream. When falling and shovelling flat areas beside the stream, the falling machine detached from the anchor machine allowing easier manoeuvring (Figure 8).

Figure 8. John Deere 909MH beside a surge pile of trees shovelled to road: Case Study 2

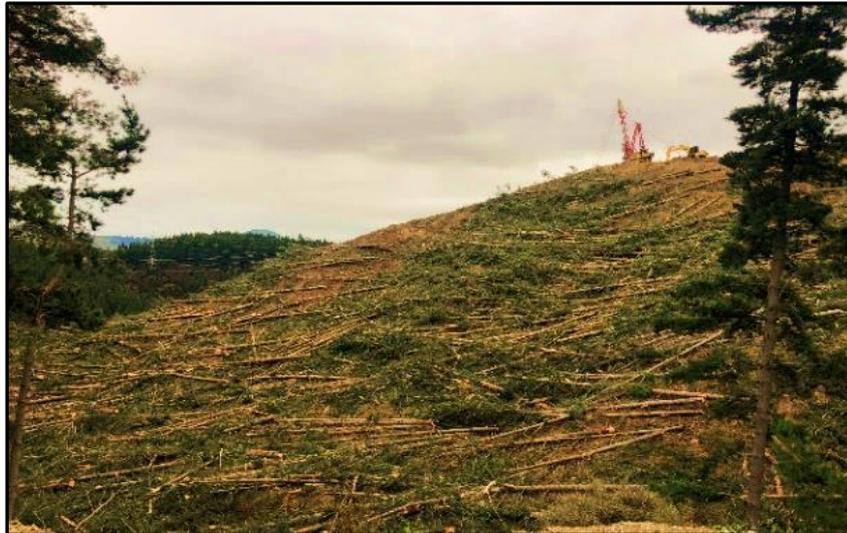
In Case Study 2, 669 trees were felled, equating to a volume of 1,493 m³. The total amount of time recorded was 2,083 minutes (or 34.7 hours), resulting in a productivity of 43 m³/SMH. Excluding delays, productivity was 88m³/PMH. On one day, the productivity was 114m³/PMH as a result of suitable falling conditions such as long even slopes and large piece size (Figure 10). The winch-

Figure 10. Site conditions that yielded the highest productivity at Case Study 2

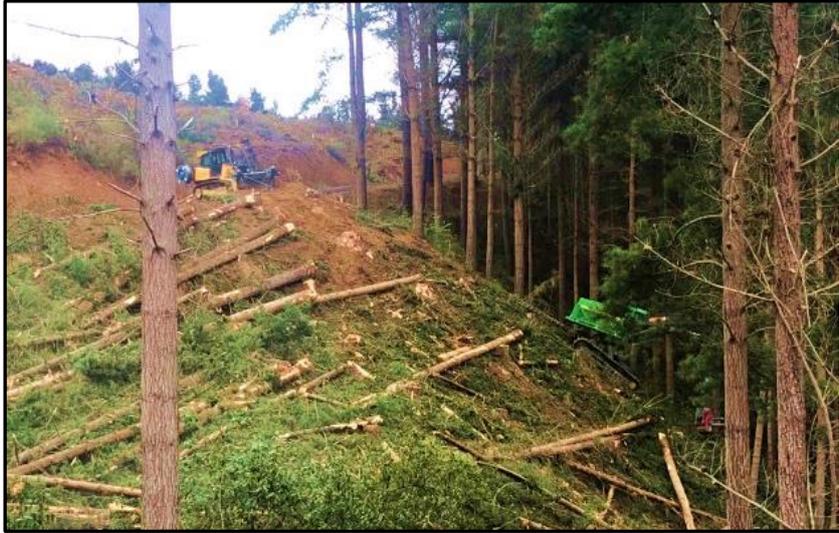
The setting can be seen in Figure 11.

Figure 11. ROB winch machine and John Deere 909MH felling machine: Case Study 2

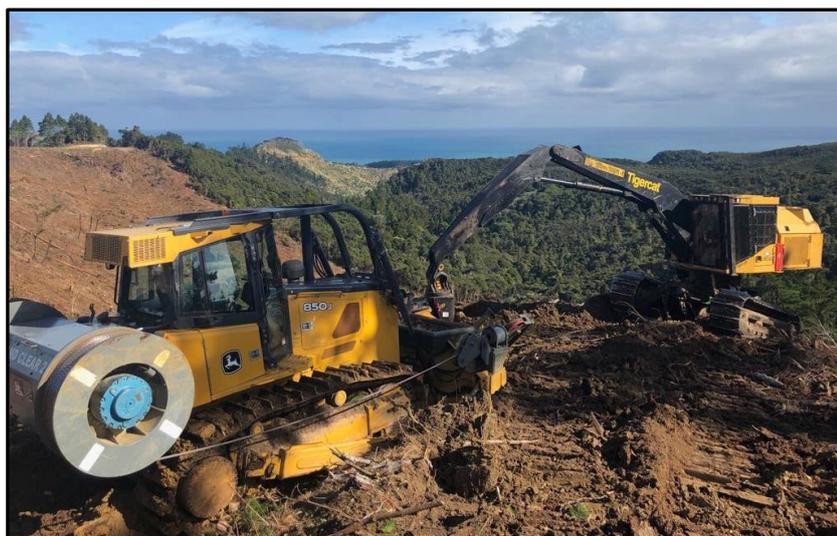
The harvesting contractor was Mold Logging Ltd and the forest management company was Summit Forests New Zealand Ltd. The winch-assist machine operating was a Remote Operated Bulldozer (ROB) manufactured by Rosewarne & May Ltd in Whangarei, based on a John Deere 850J bulldozer. The felling machine was a Tigercat LS855C with a Tigercat directional felling head (Figure 12).

Figure 12. Rob winch-assist and Tigercat LS855C: Case Study 3

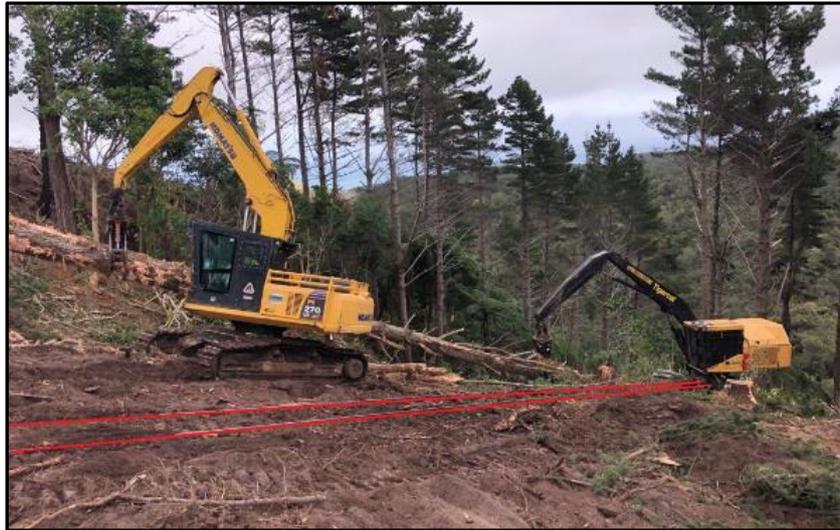
Figure 14. Komatsu PC270 assisting Tigercat LS855C with shovel extraction (winch wire rope highlighted in red).

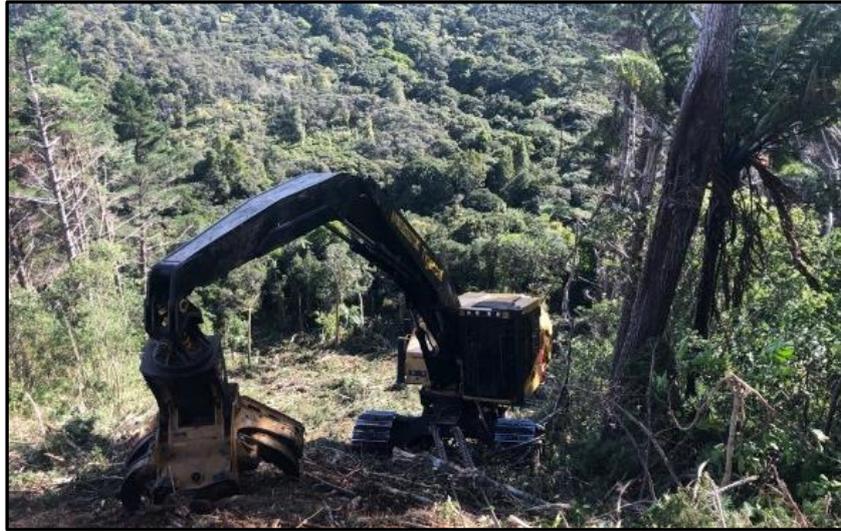
The undergrowth on site 6 was brushed and relocated away from the shovelling path. Stems being shovelled up a slope are more likely to slide down the slope if woody debris are on the ground (Figure 16).

Figure 16. Tigercat LS855C next to undergrowth with an average height of 5m.

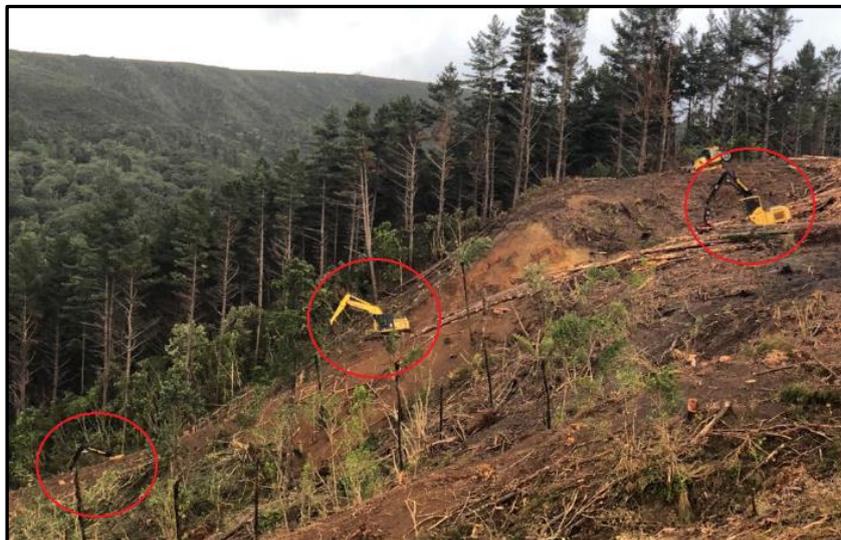
This site was a difficult setting often requiring three excavators working together on the slope (Figure 17). The winch-assisted felling machine shovelled stems to an area safe for a conventional excavator. The excavator closest to the winch-assist machine commonly cut a bench into the slope, allowing easier and safer shovelling.

Figure 17. Site conditions at Case Study 3 showing three excavators working together.

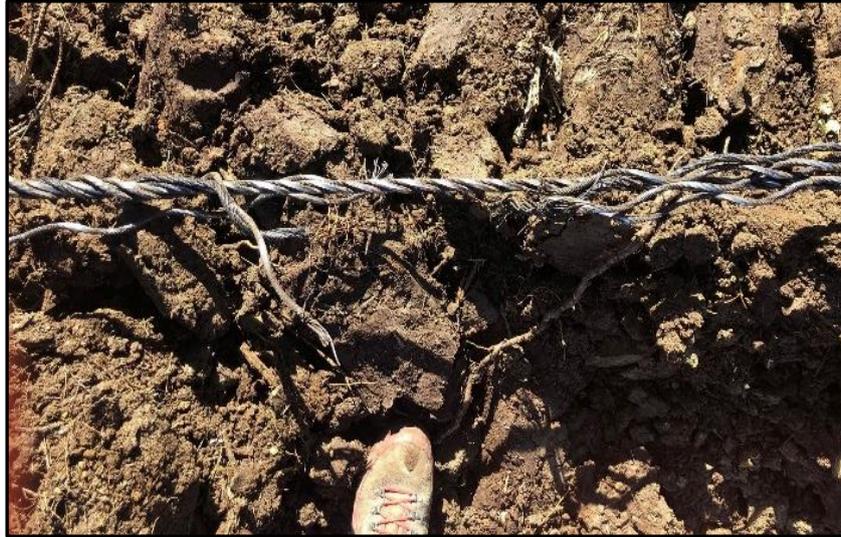
The steep slopes and rocky outcrops lead to wire rope fatigue (figure 18). The wire rope damage was a large mechanical delay, halting operations for the day requiring a mechanic to be called out and repair the wire rope.

Figure 18. Wire rope fatigue at Case Study 3 caused from repetitive use on steep slopes and rocky outcrops.

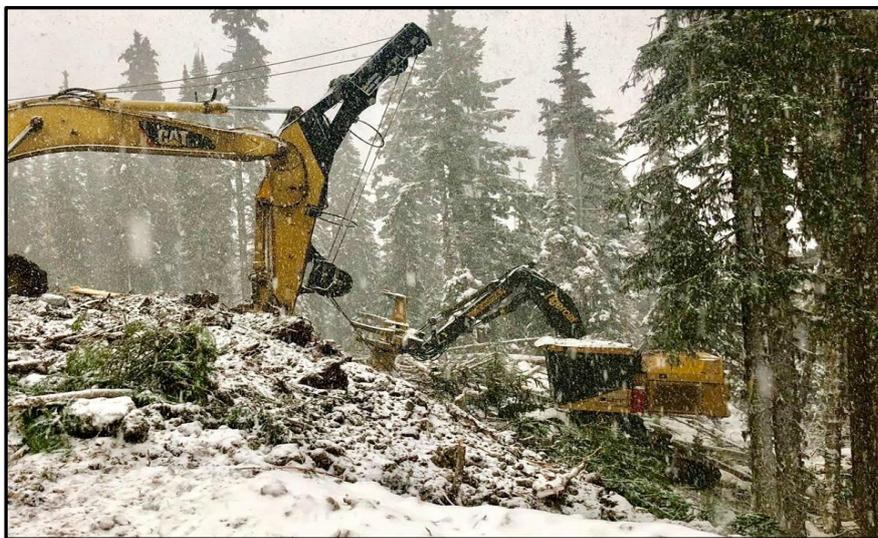
Figure 19. Tractionline winch-assist and Tigercat L870C feller buncher: Case Study 4

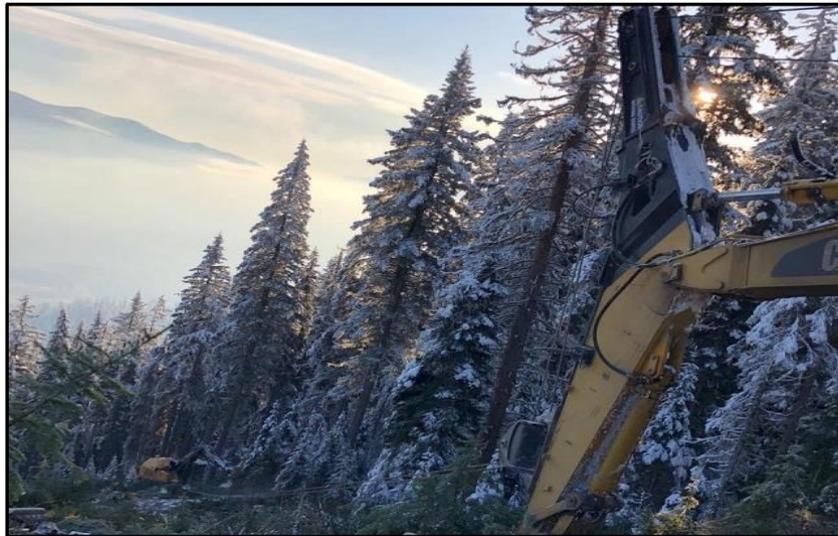
Figure 22 shows the falling machine at the end of the corridor, in this instance the corridor length is 45 metres.

Figure 22. Tigercat L870C felling a stem at the end of a 45 metre corridor at Case Study 4

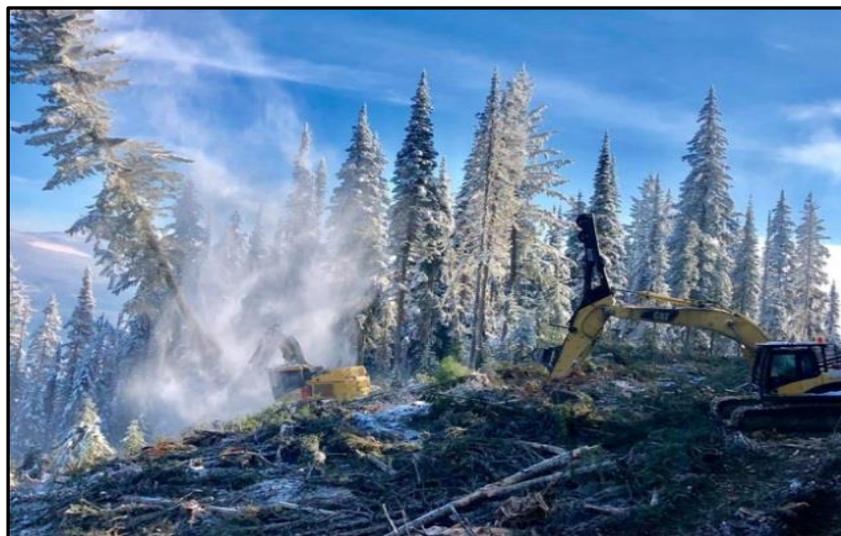
Productivity was most significantly impacted by the amount of anchor machine shifts. On the third day of the study, 46% of time was delay. A second person operating the anchor machine could speed up this task when working in short corridors. Other delays were; slashing wet areas, line handling, radio communication, refuelling, replacing a hose and poor visibility from snowfall when falling trees, requiring the operator to stop and wait (Figure 24).

Figure 24. Tigercat L870C and EMS traction line working at Case Study 4 (note snow fall above Tigercat L870C)

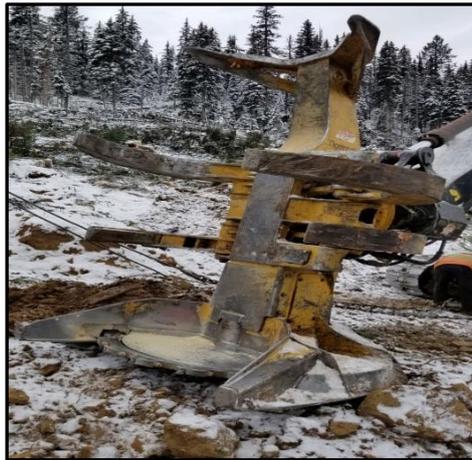
The stand had four tree species and varied age classes, with DBH ranging from 15cm to 83cm. The continuous rotating bunching saw appeared to suit these conditions well; being able to brush and having the ability to fall multiple stems in a single cycle. More than 1 tree was felled in 26% of cycles. Double cuts were required on larger trees; one cut below, and a second from above. Mechanical

delays were not common, having new equipment and with regular servicing. Bunching saws require less maintenance than feller directors as they do not have a bar and chain (Figure 25).

Figure 25. Tigercat 5702 continuous rotating hot saw

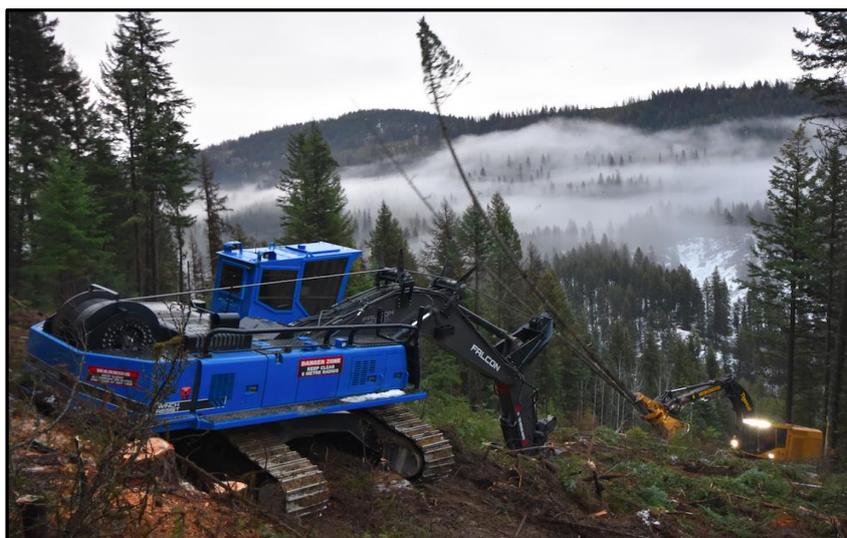
The harvesting contractor was Lime Creek Logging Ltd. currently harvesting under contract for Interfor Corporation. The anchor machine was a Falcon Winch Assist mounted to a Volvo FC3329C. The felling machine was a Tigercat LX870D with a Tigercat 5702-26 continuous rotation bunching hot saw (Figure 26).

Figure 26. Falcon winch-assist and Tigercat LX870D: Case Study 5

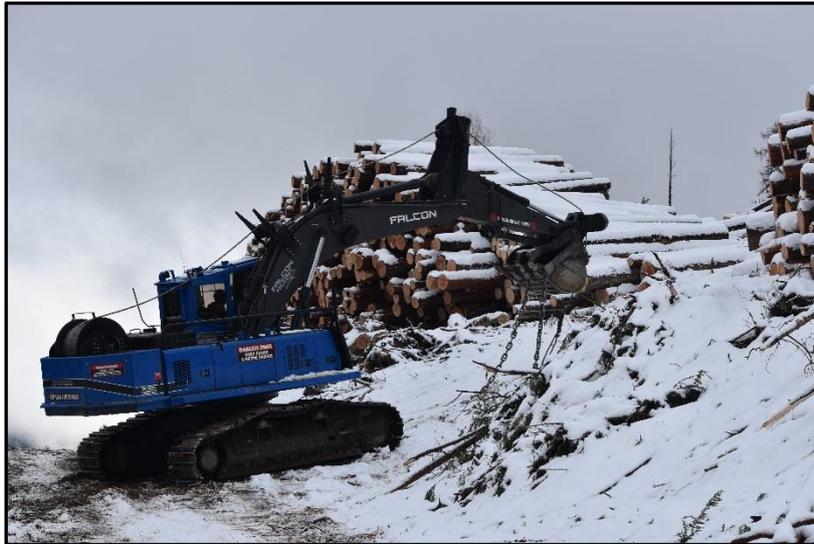
On the second day 3 ½ hours was required to move both machines to a new setting. Figure 29 shows the Falcon Winch Assist ready to shift setting. The new setting required untethered harvesting to take place; clearing skid roads and falling of trees close to the road.

Figure 29. Falcon Winch Assist moving setting: Case Study 5

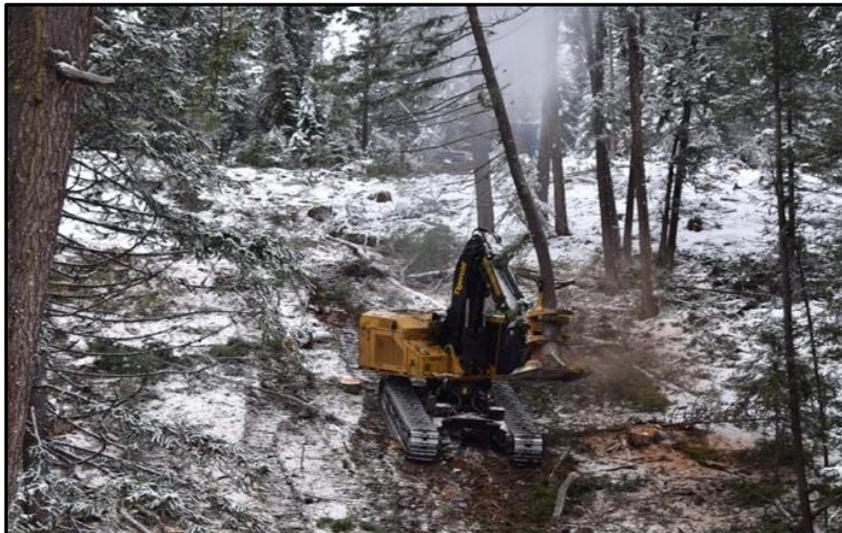
Extraction was done by a method the operator referred to as “packing” given steep slopes observed didn’t exceed 100m in length. “Packing” was defined as walking the machine while carrying the cut tree stems. In this way stems are extracted to either the top or bottom of the slope where a skidder can reach them. This meant that extraction using a yarder or other machine was not required.

Figure 30. Tigercat LX870D packing a stem to the bottom of the corridor at Case Study 5

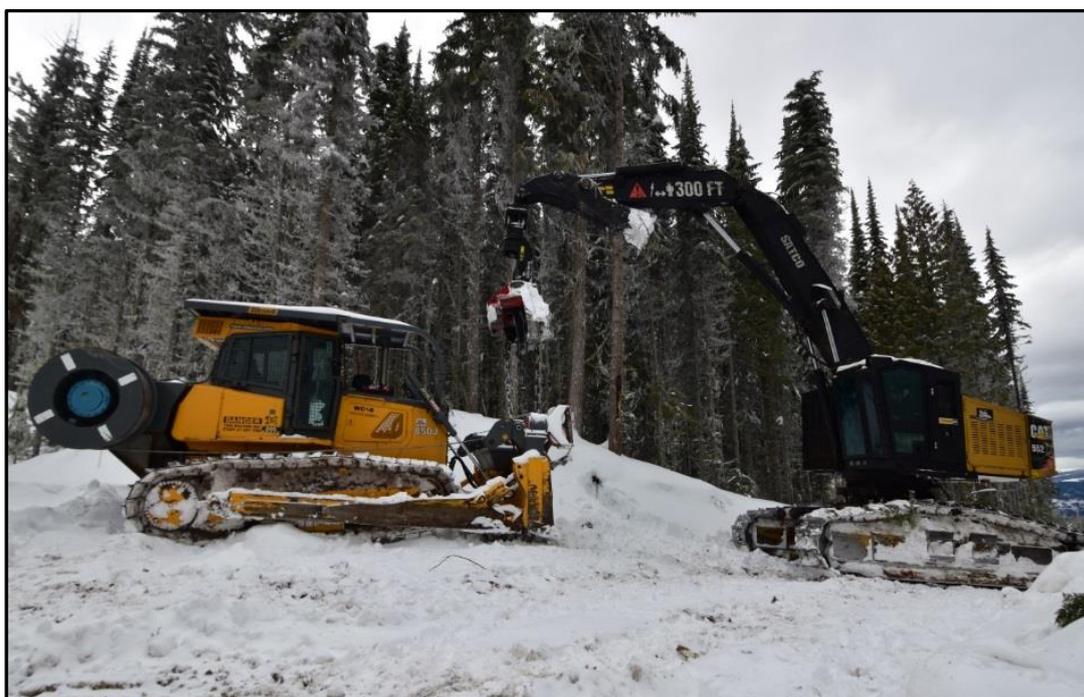
The harvesting contractor was Gorge Creek Logging Ltd. currently harvesting under contract for Tolko Industries Ltd. The anchor machine was a Remote Operated Bulldozer (ROB) mounted on a John Deere 850J base machine. The felling machine was a levelling Cat 552 with a Satco feller director head and heel (Figure 31).

Figure 31. ROB winch-assist and Cat 552: Case Study 6

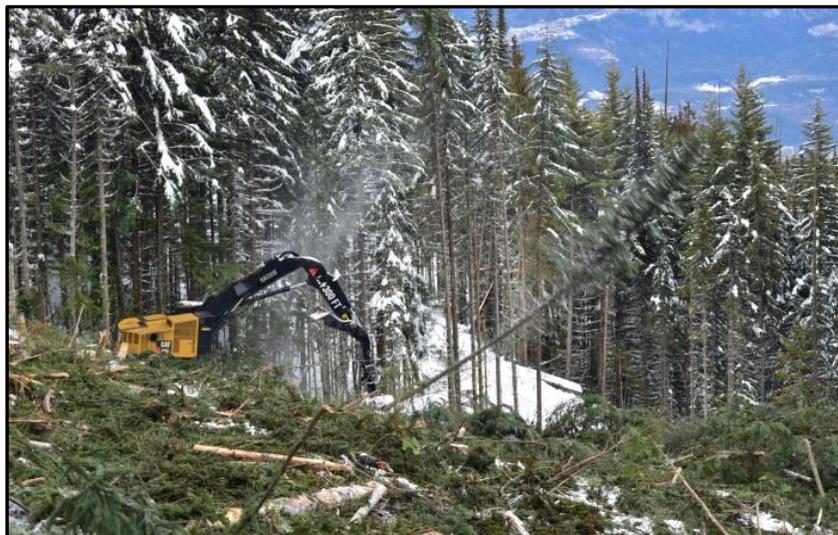
The harvest system observed was a steep slope ground-based operation. This system has a high utilisation as it is solely a winch-assist crew with two machines whereby it works only in winch-assist required terrain. The slope lengths observed were between 80 and 120 metres (Figure 34) and the method of extraction involved falling and shovelling in the same process. This took place as the machine made its way down the slope, falling up to 10 trees before shovelling these stems 20 m to the next heap and then repeating the operation.

Figure 34. Operating conditions at Case Study 6

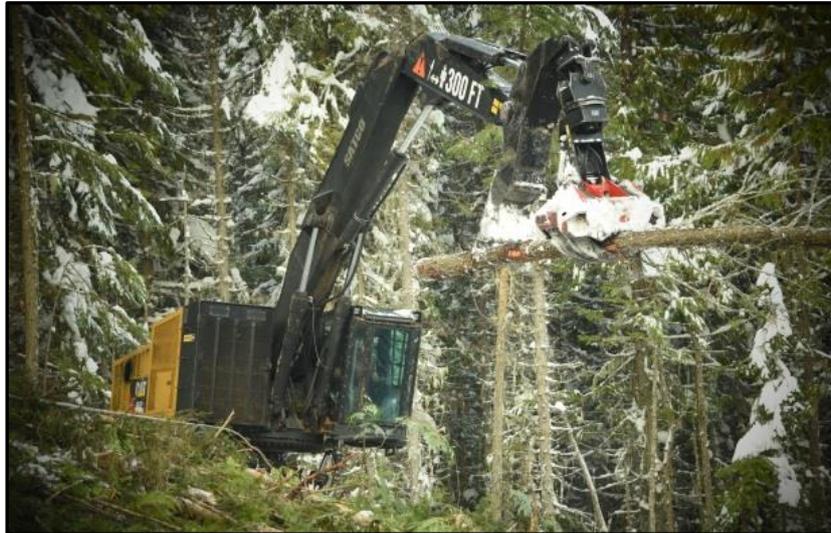
The falling machine was equipped with a heel, which improved the shovelling phase (Figure 35). At the end of the corridor, a large surge pile awaits extraction or processing by another logging company.

Figure 35. Cat 552 applying the heel while shovelling

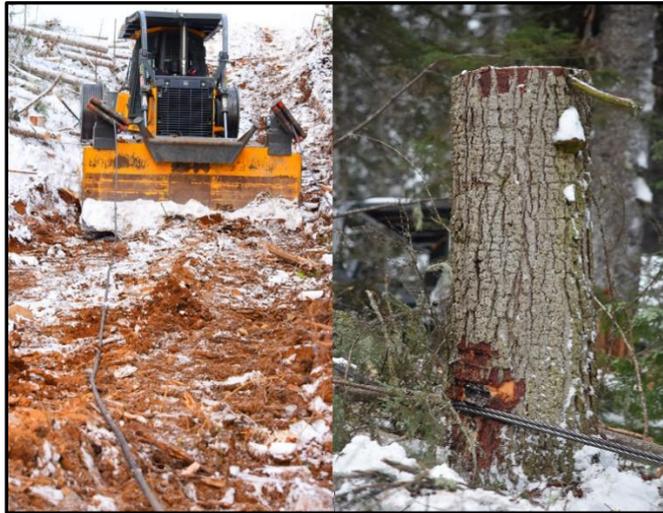
From the researcher's point of view, the high utilisation was a result of frequently using catch trees to limit the number of anchor shifts (Figure 37).

Figure 37. Example of a catch tree being used at Case Study 6
