Report No. H064

Development of a Prototype Bark Detection System for a Fixed Debarking Facility

**Research Provider:
Applied Teleoperation Limited
and
Lincoln Agritech Limited**

Date: 31 December 2023

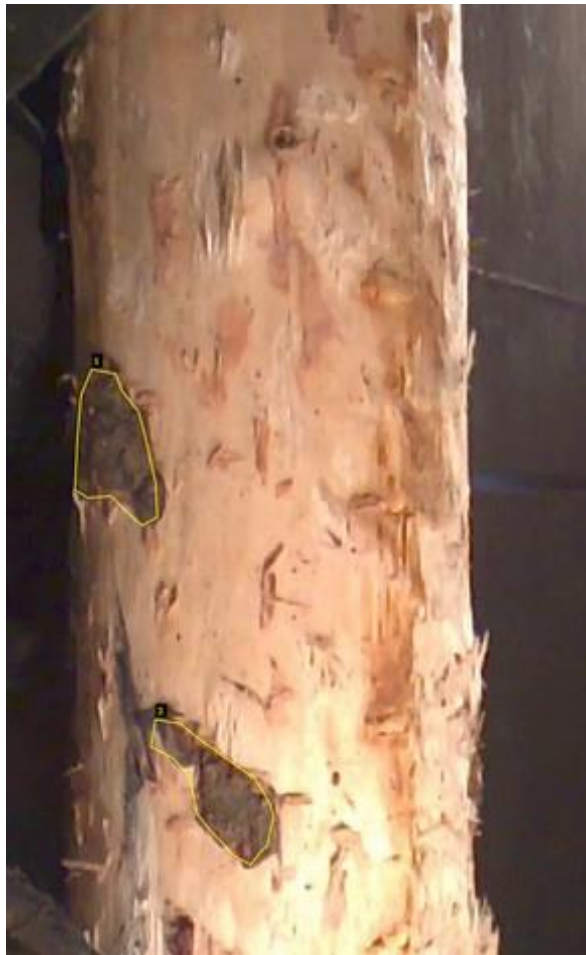
Figure 1: Example of a log image that has bark regions manually annotated for training.

Around 80% of the labelled images were used for training the model and 20% were kept apart to verify the model's accuracy on unseen examples. A selection of these labelled examples of bark were verified by experts from FGR to ensure that bark and cambium were distinguished. Figure 1 shows an example of a log image that has bark regions manually annotated for training. In this example two labels have been added to the data set.

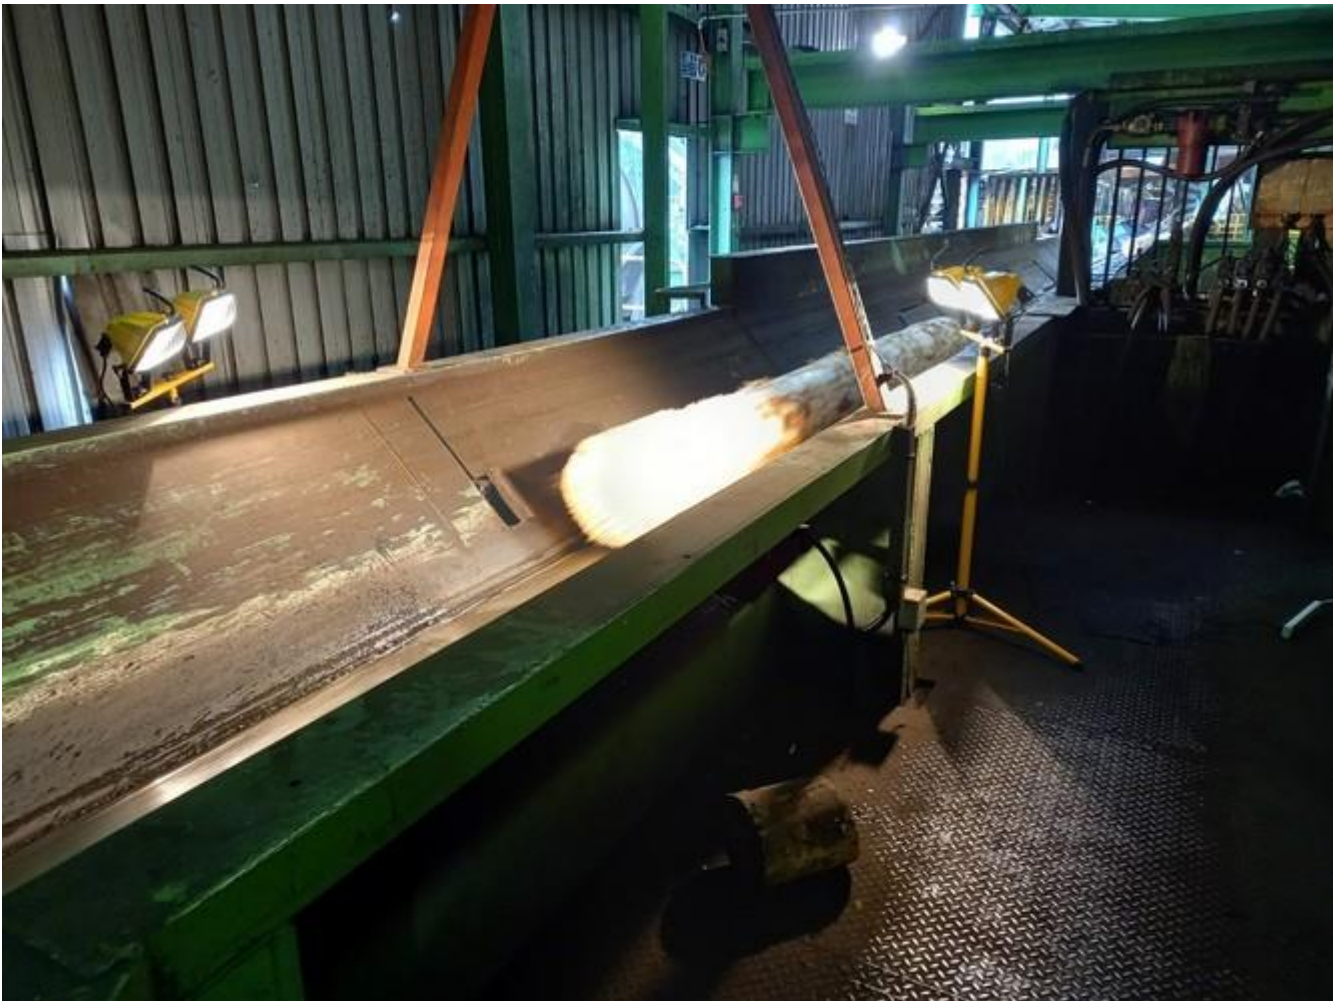
Figure 2: Installation of the lighting.

Representatives of FGR, ATL and KPP met at KPP to choose a location for the installation. The system was installed on a conveyor to measure logs post debarking, bucking and removal of reject material. The logs travel towards the camera at a speed of up to 12kph (3.33 m/s). Temporary lighting was used for the development of the prototype system. Figure 2 shows the installation of the lighting. Halogen lamps were chosen for testing as they produced a broad natural spectrum of light, and they caused no problems with image flicker or banding.

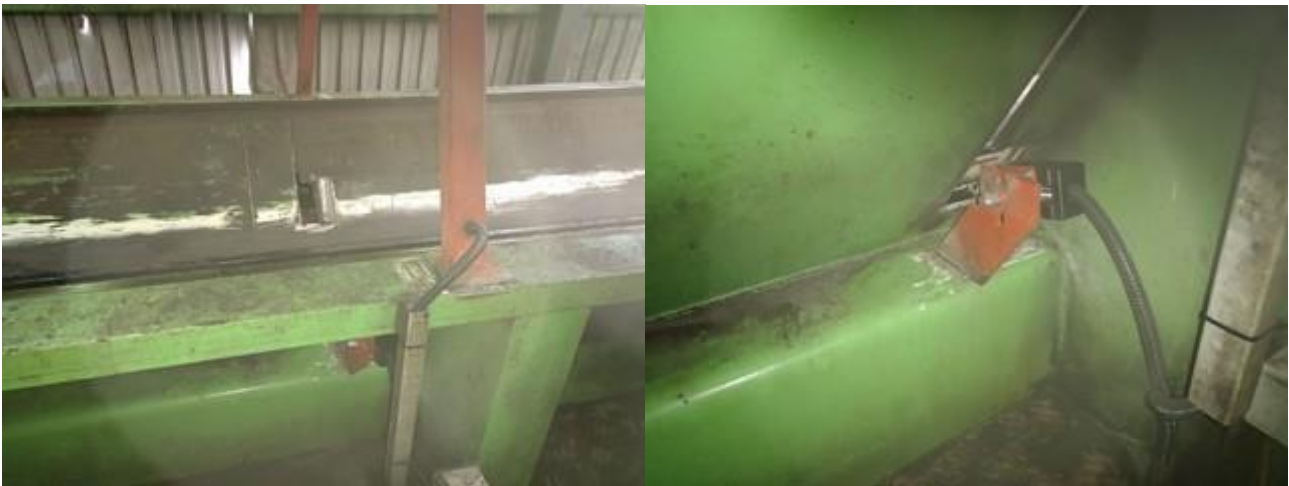
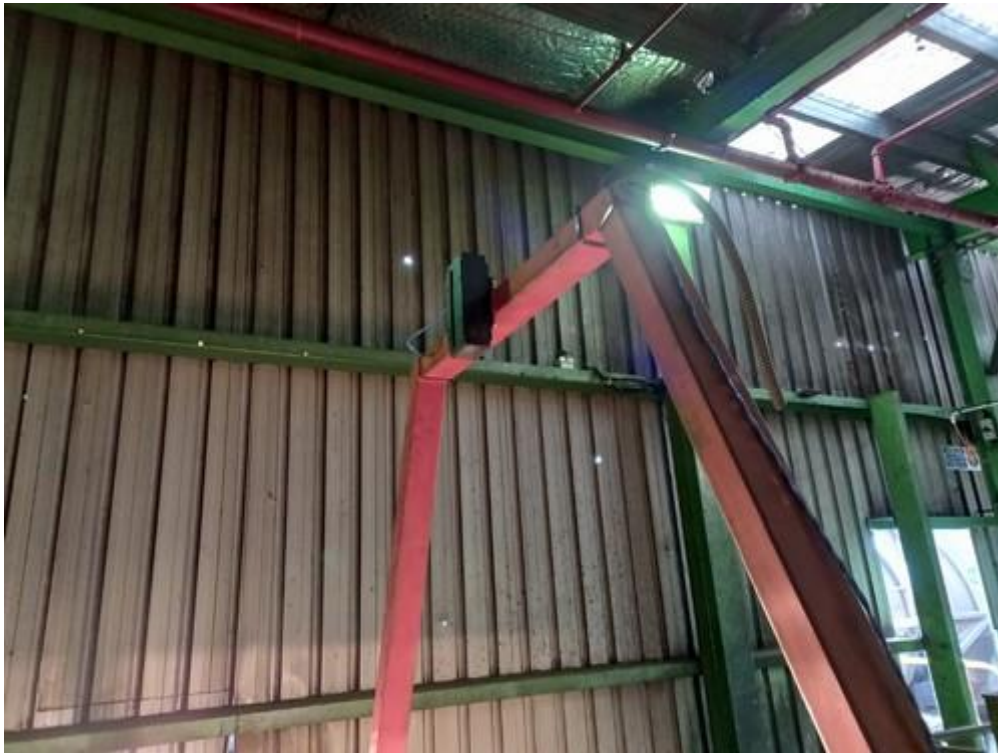
Figure 3: Cameras were located on either side of the conveyor (top right and top left) and one camera was positioned above the conveyor (bottom)

Three cameras were installed. Cameras were located on either side of the conveyor and one camera was positioned above the conveyor as shown in Figure 3.

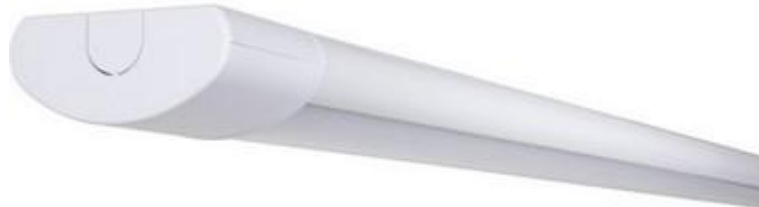
Figure 5: “Urban Interior Mons.60 LED batten PLU 3451” high power lighting.

LED lights run cooler than halogen lamps and require less maintenance. However, the LED lights that were tested in the initial stages of development caused banding of the video due to the rapid flicker of the LED lights. Later in the project, further testing was done on a selection of lights, and an LED light that did not cause banding was found. The model was: “Urban Interior Mons.60 LED batten PLU 3451”. The higher power version “Urban Interior Mons.60 batten PLU 3293” (Lightingplus, 2023), shown in Figure 5, is recommended for permanent installations.

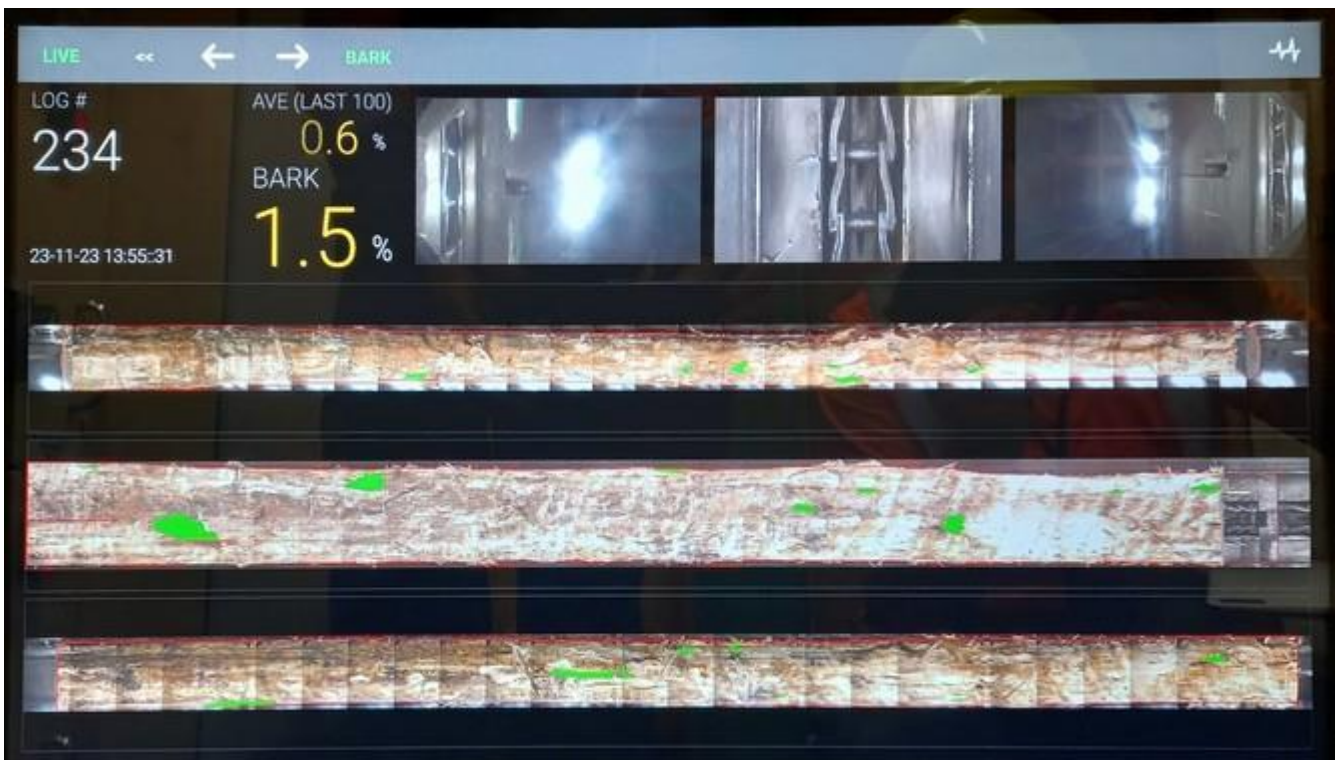
Figure 7: Screenshot of the operator’s screen

A photo of the operator’s screen is shown in Figure 7 below.

The bark overlay can be turned on and off via the touchscreen. Live video streams from the three cameras are shown at the top of the screen.

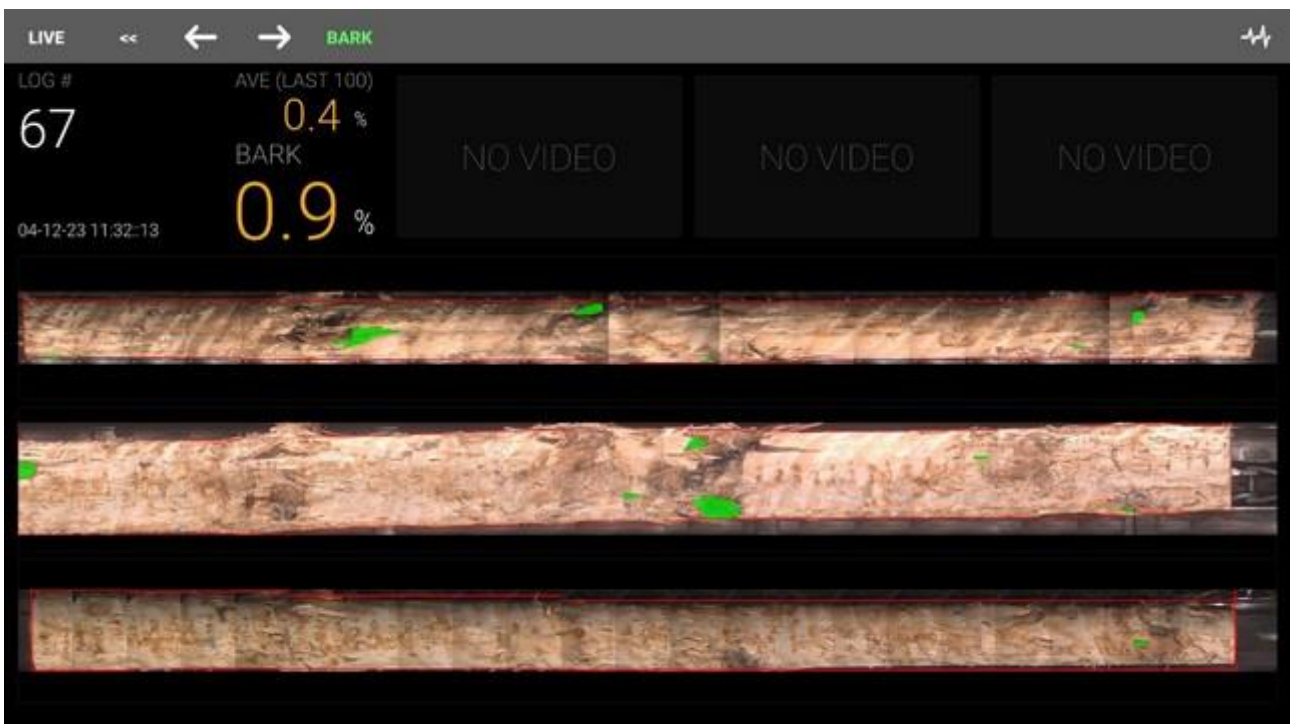
Another example is shown below.
