The decay resistance of some wood species used as framing

Final report on the condition of samples

Ian Simpson and Tripti Singh

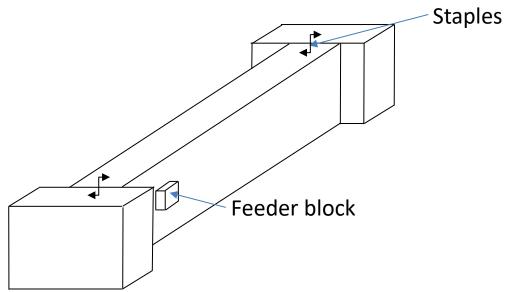
Figure 1: Diagram showing I-frame

Ten 900 mm long samples were cut for each group. A 100 mm long block was cut from both ends of the samples and both ends of the 100 mm blocks were end coated. The 100 mm blocks were then stapled across the ends of the 700 mm sample to form an "I" shape (Figure 1). The "I" shaped samples were soaked in a tank of water for two hours to raise the moisture content and to simulate rain wetting that may occur during building construction. Moisture meter measurements taken on the timber after water soaking were around 30% moisture content.

Feeder blocks were inoculated with *Antrodia xantha* and *Oligoporus placenta* fungus and grown in the laboratory until the fungi were established. The strain of these two fungi were isolates from the leaky buildings (Stahlhut 2008). The feeder blocks were nailed to each "I" sample, with *A. xantha* fungus attached approximately 5-10 mm from one end of the sample and *O. placenta* fungus attached approximately 5-10 mm from the other end of the sample (Figure 1).
