REPORT

Volume 22 No. 20 1997

BELLIS BE85 CABLE HAULER

Dave Palmer
Tony Evanson

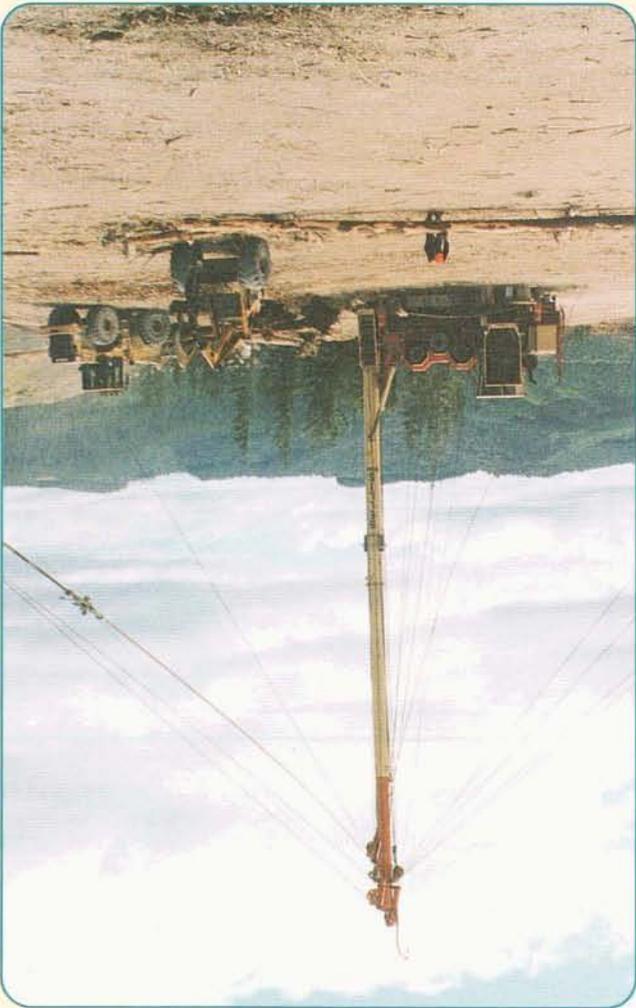
Figure 1 - Bellis BE85 Hauler

- a larger 338kW (450hp) Cummins power plant
- an Allison CRT transmission (six forward:one reverse)
- a hydraulically raised tower
- a hauler cab with conventional controls on a panel split into left and right sections, allowing floor-to-ceiling vision.

- Some instances of the hauler tower sinking into the ground. A 50% larger tower base-plate is now available.
- Sundry small teething troubles with the machines when delivered (such as small hydraulic leaks) - nothing major.
