# **A SURVEY OF THE QUALITY OF MECHANISED LOG-MAKING IN NEW ZEALAND**

**Tony Evanson**

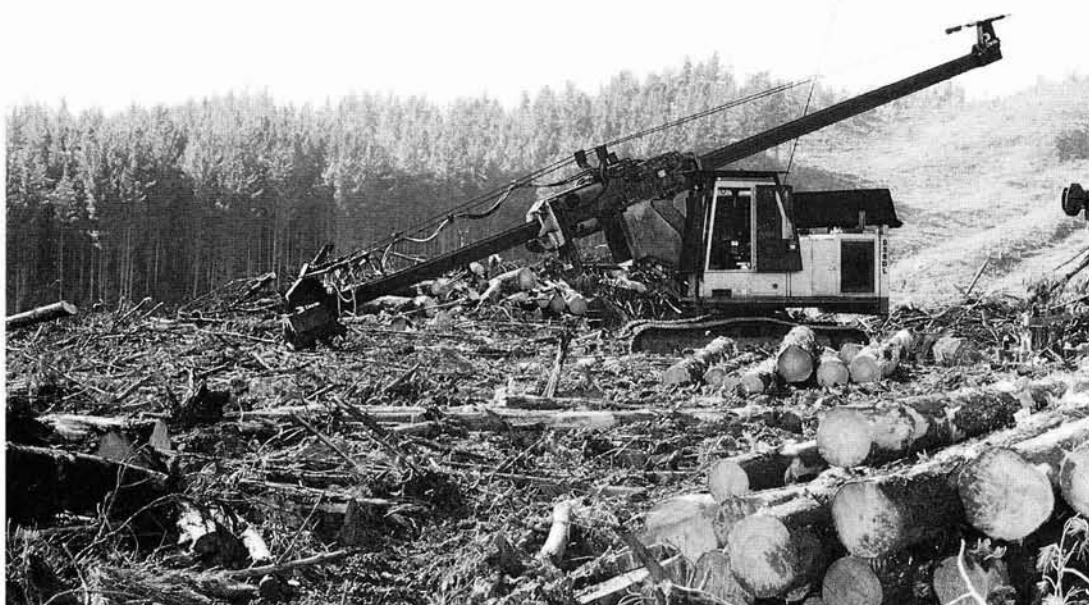
*Figure 1 - A Denis DM3000 stroke delimber*
