THE SCRUB MUNCHER - A DISC SLASH BREAKER FOR SITE PREPARATION

Peter Hall

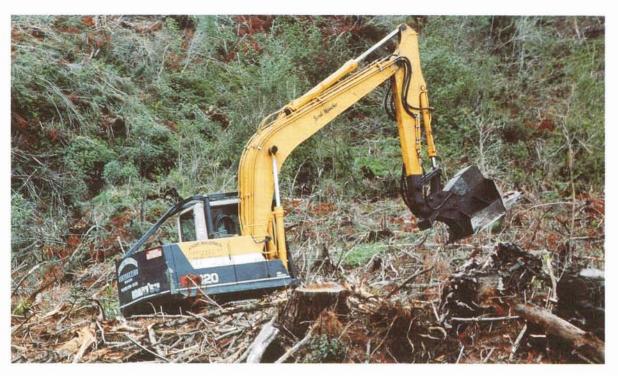
Figure 1 - The Scrub Muncher mounted on a PC120 excavator treating heavy slash and undergrowth

The Scrub Muncher consists of a hydraulically powered 130 cm diameter

disc with 16 blunt teeth for breaking up the slash. The disc (horizontal) spins at 600 rpm. The Scrub Muncher is fitted with a hydraulic grab at the rear of the disc housing that enables it to grasp logs and place them in a heap rather than simply push them aside. The Scrub Muncher weighs 1.2 tonnes. The 12 tonne excavator is a relatively small base machine and the Scrub Muncher appeared to be working close to the limit of its capabilities. A larger unit may have been able to work more quickly. However, a larger machine would have a higher capital cost and so the overall cost per hectare may not be reduced.

The Scrub Muncher breaks the slash, especially branch material and light scrub, into smaller pieces. This lowers the overall height of the slash. The pieces it produces are often 0.5 m to 1.0 m long. The range of sizes is large with some pieces as small as 3 to 4 cm. It does not attempt to break up the larger diameter stem wood. The treatment makes the site easier to walk across, and to plant, as the broken up slash can easily be kicked aside to access the The treatment does not reduce the soil. volume of slash but reduces the size of the pieces and the amount of hindrance from the slash.

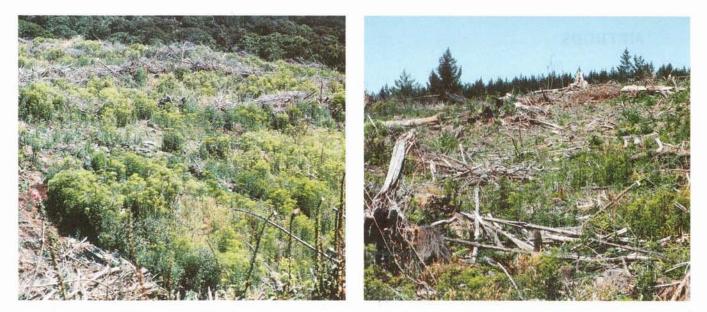
Figure 2 - Windrowed area on left, Scrub Muncher treated area on right, nine months after planting

A survey of a site re-established in 1995 was completed. Part of the block had been treated by the Scrub Muncher and part by excavator windrowing. Survivals in the block were similar at 83% and 84% respectively. Tree growth was not assessed as animal browsing in both parts of the block had masked any treatment effect. However there was a measurable difference in vegetation cover between the two treatments which may be related to the slash treatment (Table 6). There was a much greater proportion of the site free of weeds in the area treated by the Scrub Muncher and the weeds that were present were generally shorter (Figure 2). The exact reason for the reduction in weeds in the area treated by the Scrub Muncher is not known. The timing of the operation may be important.

• The creation of a layer of slash at ground level appeared to have some effect on weed growth. The weed re-growth at one site was noticeably less than that at a windrowed site of the same age nine months after the treatment.
