# Supercritical CO<sub>2</sub> dewatering of *E. nitens*. Results of Scion's core funded experiments

Bernie Dawson, Hamish Pearson, Rosie Sargent

<b>Report title</b>	Supercritical CO <sub>2</sub> dewatering of <i>E. nitens</i> . Results of Scion's core funded experiments
<b>Authors</b>	Bernie Dawson, Hamish Pearson, Rosie Sargent Scion
<b>Client</b>	Specialty Wood Products Partnership
<b>Client contract number</b>	
<b>MBIE contract number</b>	
<b>SIDNEY output number</b>	
<b>Signed off by</b>	Doug Gaunt
<b>Date</b>	August 2018
<b>Confidentiality requirement</b>	Confidential (for client use only)
<b>Intellectual property</b>	© New Zealand Forest Research Institute Limited. All rights reserved. Unless permitted by contract or law, no part of this work may be reproduced, stored or copied in any form or by any means without the express permission of the New Zealand Forest Research Institute Limited (trading as Scion).
<b>Disclaimer</b>	<p>The information and opinions provided in the Report have been prepared for the Client and its specified purposes. Accordingly, any person other than the Client uses the information and opinions in this report entirely at its own risk. The Report has

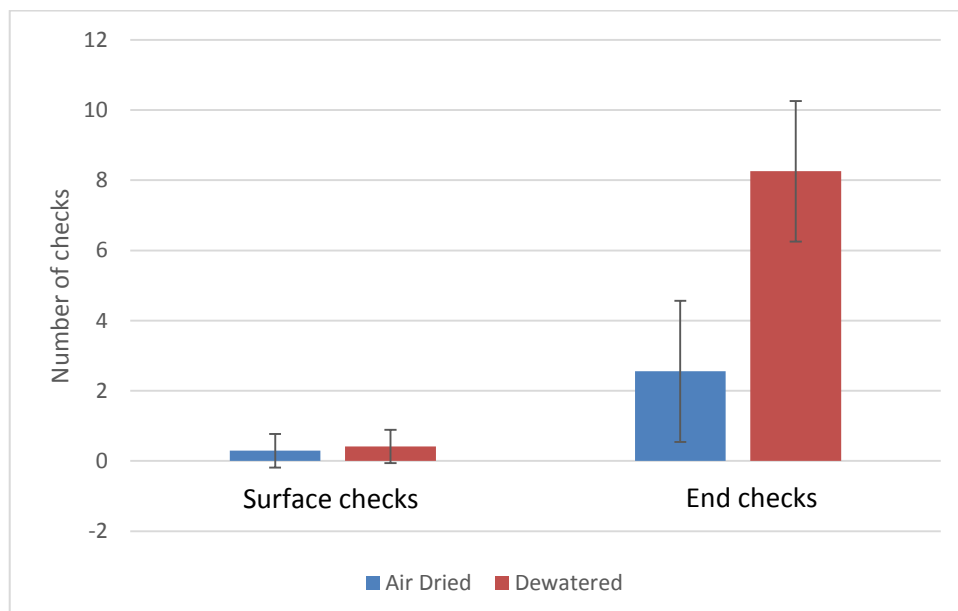
The number of checks on the faces and ends of the boards are shown in Figure 5. The numbers of surface checks are very low in both the air dried and dewatered boards. The air dried boards had an average of two end checks per board, but the dewatered boards had an average of eight end checks per board. End checking is not necessarily an indication of internal (within-ring) checking, and levels of within ring checking would need to be confirmed in a separate study.

**Figure 5** Number of checks on the faces and ends of specimens following drying to 12% MC
